Special Coverage Adjustment

17306 Rear Seatbelt Buckle May Not Unlatch

Reference Number: N2097250

Release Date: September 2017
Revision: 00

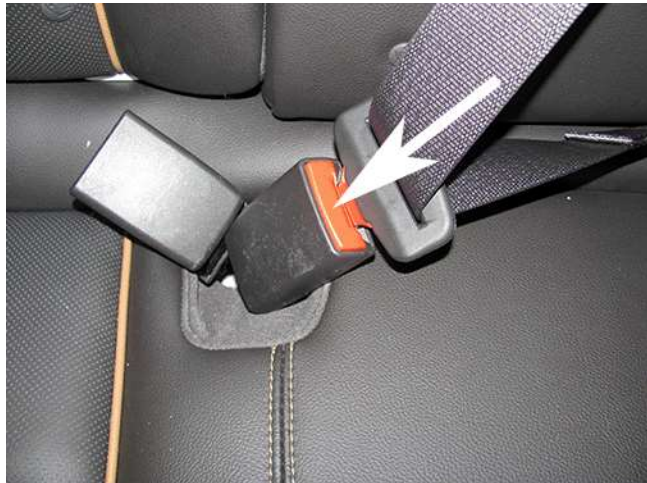
4860267

1. Verify the customers concern. Latch the affected seat belt (if it is not already latched). Push the red button on the seat belt buckle to release the latch plate on the retractor side of the seat belt.
 - If the latch plate releases and does not show any sign of binding, repeat the procedure to verify the seat belt is functioning. If the seat belt releases and latches correctly, no further action is required.
 - If the seat belt latch plate does not release, proceed to step number two.
