Service Update

17385 Electronic Park Brake Module Fasteners Not To Torque

Reference Number: N172116490

Make	Model	Model Year		RPO	Description
		From	To		
Chevrolet	Impala	2018	2018

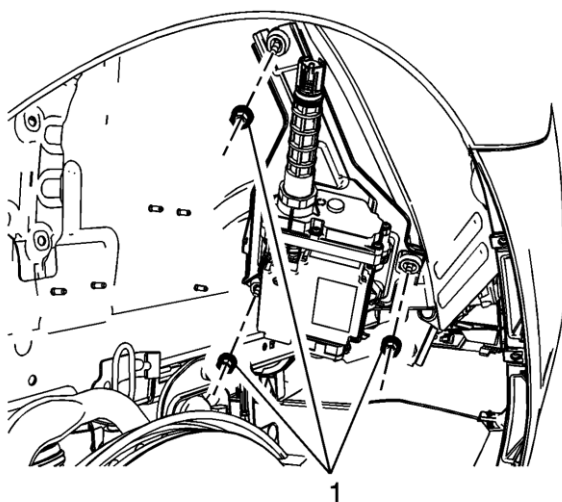
2752681

Condition	The Electronic Park Brake (EPB) module securing nuts may not have achieved proper torque during manufacturing, and may loosen over time.
Correction	Tighten the EPB module/bracket assembly securing nuts to the proper torque.

2. Locate the electronic parking brake control module nuts (1).
3. Verify the nuts are torqued to 10 Nm (89 lb in).
4. Install the left rear wheelhouse panel liner. Refer to *Rear Wheelhouse Liner Replacement* in SI.
