Service Bulletin

Bulletin No.: 06-03-09-004J

Subject: Squeak Noise from Rear of Vehicle (Lubricate Rear Leaf Springs)

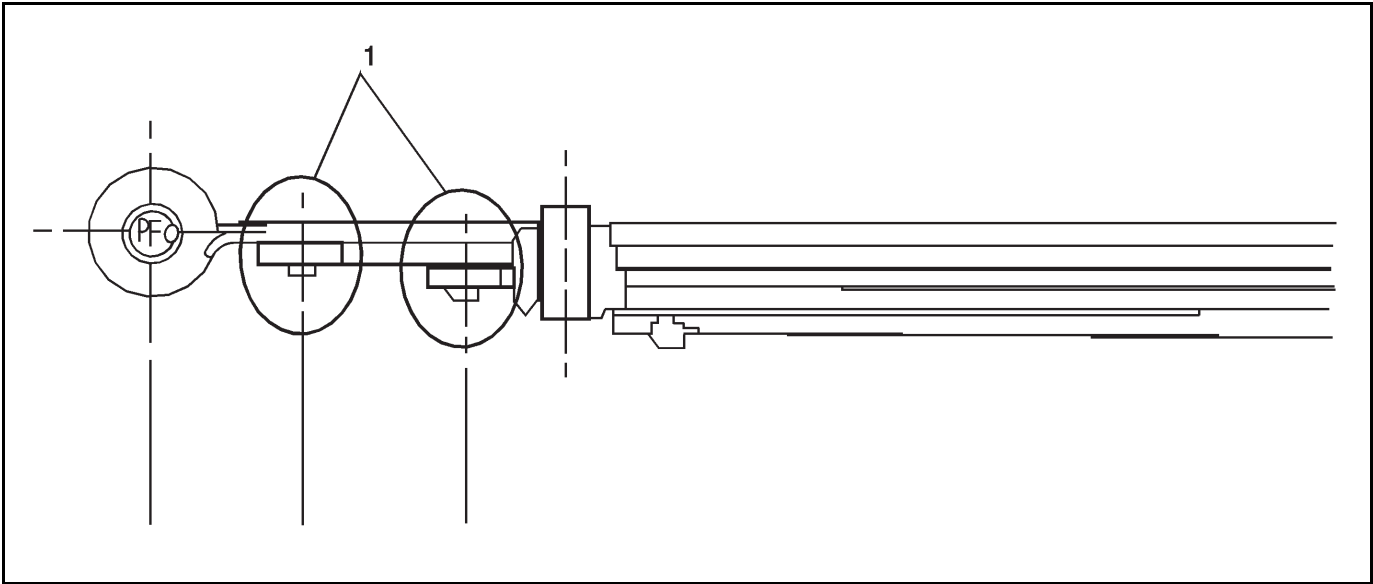
1826776

Some customers may comment about a squeak noise coming from the rear of the vehicle. During normal operation, certain vehicles may exhibit a squeaking noise that may be traced to the rear leaf springs. While this noise is an operating characteristic of leaf springs, the frequency and severity of this noise will be affected by the roads that the vehicle is driven on.

This condition may be due to debris getting between the leaf springs.

1. Raise the vehicle on a frame lift-type hoist.
2. Inspect the springs for damage. If none is found, proceed to the next step.
3. Pressure wash the rear leaf springs to remove as much dirt and grit as possible.
4. Dry the springs with compressed air.
