Service Bulletin

Bulletin No.: 16-NA-250

Subject: Slow Cranking, Dead Battery and/or No Start

Brand:	Model:	Model Year:		VIN:		Engine:	Transmission:
		from	to	from	to		
Chevrolet	Corvette	2014	2018			LT1, LT4

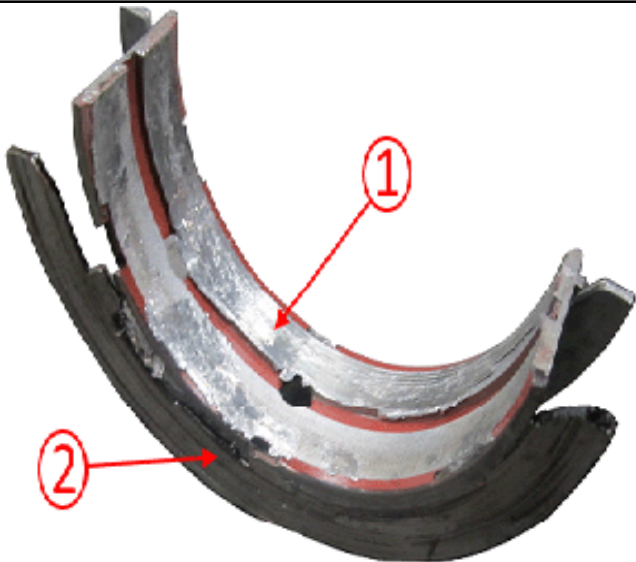
<p>4567041</p> <p>This may be caused by excessive pressure to the engine crankshaft thrust bearing (1), by forward pressure from a mis-aligned driveline support assembly.</p>

If the driveline support assembly has been removed from a previous vehicle repair, it is required that the propeller shaft hub clamp (Automatic Transmission) or input shaft front bearing (Manual Transmission) be realigned. Follow the procedures outlined in SI.
