# Service Bulletin

Bulletin No.: 16-NA-405

Date: September, 2017

**Subject:** Poor Engine Performance in Extremely Cold Weather Conditions, PCV Bypass Hose and Charge Air Cooler Icing, Malfunction Indicator Lamp (MIL) Illuminated - DTC P0299, P0236, P2227, P00C7 Set

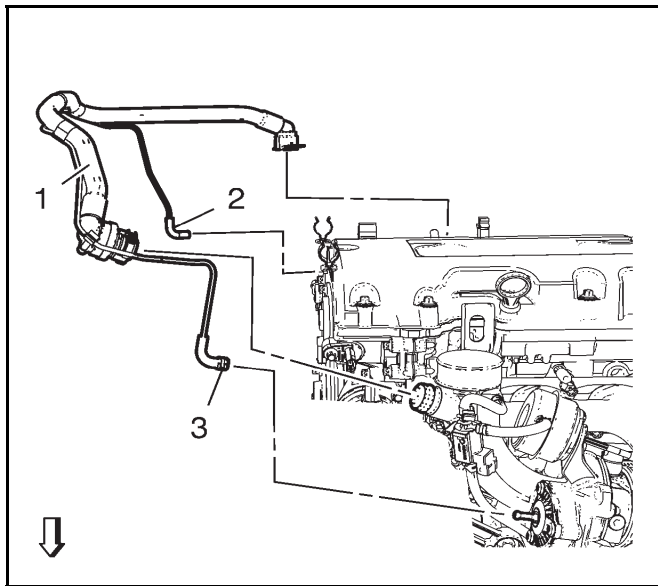
2191937

**Note:** Original PCV pipe with vacuum line attached removed from vehicle for illustrative purposes **ONLY**.
