Service Bulletin

Bulletin No.: 17-NA-005

Subject: Information on Liftgate Glass Breakage

Brand:	Model:	Model Year:		VIN:		Engine:	Transmission:
		from	to	from	to		
Chevrolet	Equinox	2015	2017			All	All

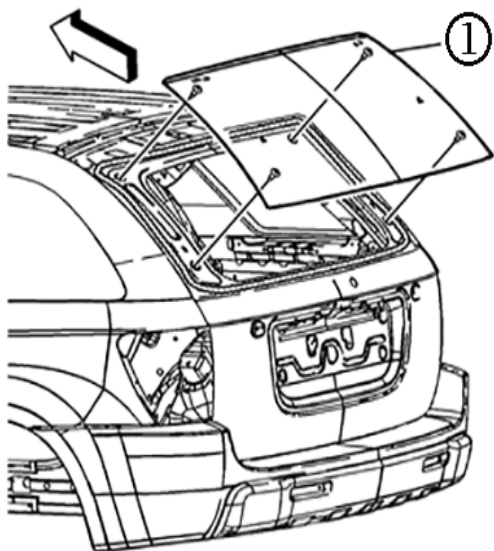
4794142

Involved Region or Country	North America, Israel
Condition	Some customers may comment that the liftgate glass has shattered, or blown outward, while driving vehicle or when a side door was closed.
Cause	The cause of the condition may be a weakness/defect in the liftgate glass. In some cases, the liftgate spoiler may also be found to contact the glass, causing an interference condition that damages the glass.

First investigate the cause; inspect the liftgate for any evidence of physical damage and inspect rear of vehicle for any unsecured objects which may have impacted the glass.

Replace liftgate glass (1) under warranty if failure is determined to be caused by glass defect. Refer to *Liftgate Window Replacement* in SI, **PLUS** follow the additional Spoiler Kit Insulator Pads Installation steps below:
