## **Service Bulletin**

Bulletin No.: 17-NA-294

Subject: Radio Control Display is Scrambled, Split, Pixilated, or Displays Vertical Lines

Brand:	Model:	Model Year:		VIN:		Engine:	Transmission:
Біапи.	wiodei.	from	to	from	to		
Chevrolet	Traverse	2018	2018			All	All

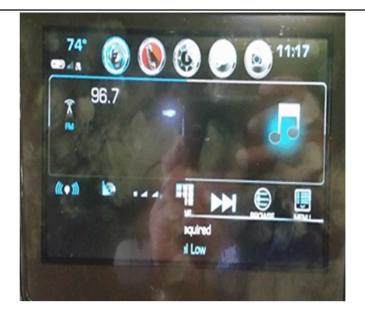
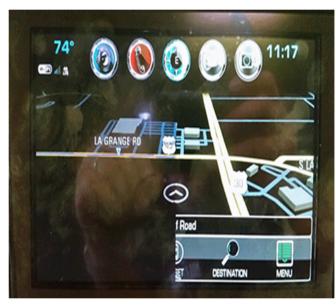
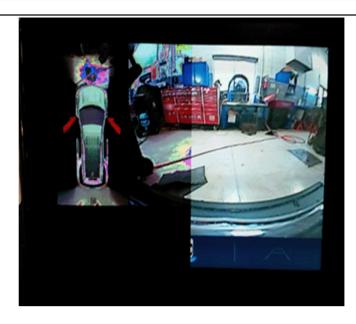
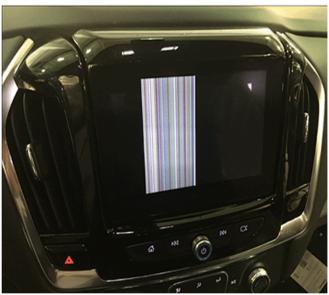
Upon inspection, the technician will not find any related codes stored and normal audio from the speakers will be experienced as well.

Cause	This may be the result of the internal memory being overwritten during certain module communication sequences.		
Γ	Correction	If this concern is encountered, replace the radio control (ICS) assembly.

If you encounter a vehicle with the above concern, replace the radio control (ICS) assembly. Refer to Radio Control Assembly Replacement with IO5, IO6 in Service Information for detailed instructions.
