Service Bulletin

Bulletin No.: 17-NA-295

Subject: Rattle Type Noise Heard in Cargo Area and/or Missing Tire Inflator Spacer in the Inflator Kit

Brand:	Model:	Model Year:		VIN:		Engine:	Transmission:
		from	to	from	to		
Chevrolet	Volt	2017	2018

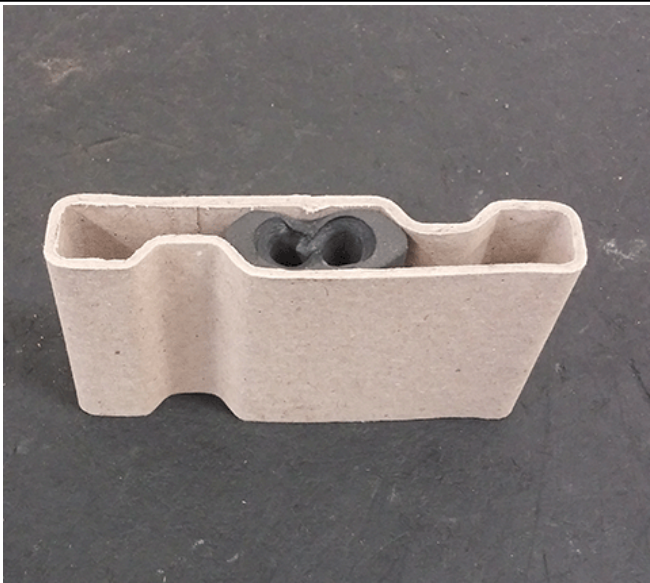
4481731

This condition may be caused by a missing cardboard spacer for the tire inflator bag that was not installed at the assembly plant.

Install new cardboard spacer for the tire inflator bag
