Service Bulletin

Bulletin No.: 17-NA-298

Subject: Headliner Sag

Brand:		Model:	Model Year:		VIN:		Engine:	Transmission:
	Branu.	woder.	from	to	from	to		
	Chevrolet	Camaro Coupe	2016	2018			All	All

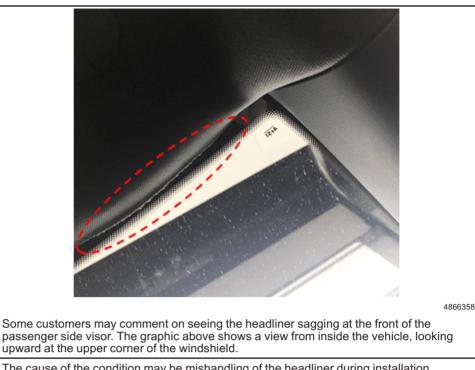
Condition 2

passenger side visor. The graphic above shows a view from inside the vehicle, looking upward at the upper corner of the windshield.

Cause 2 The cause of the condition may be mishandling of the headliner during installation. If either condition is evident, replace the headliner. Refer to Headlining Trim Panel Replacement in SI. Correction Important: Caution should be taken during installation not to cause damage to the replacement headliner. Also ensure the RRAB connector routing issue is eliminated.
