Service Bulletin

Bulletin No.: 17-NA-302

Subject: Dust Buildup Around Filler Cap Area

Brand:	Model:	Model Year:		VIN:		Engine:	Transmission:
		from	to	from	to		
Chevrolet	Silverado	2017	2018				
GMC	Sierra

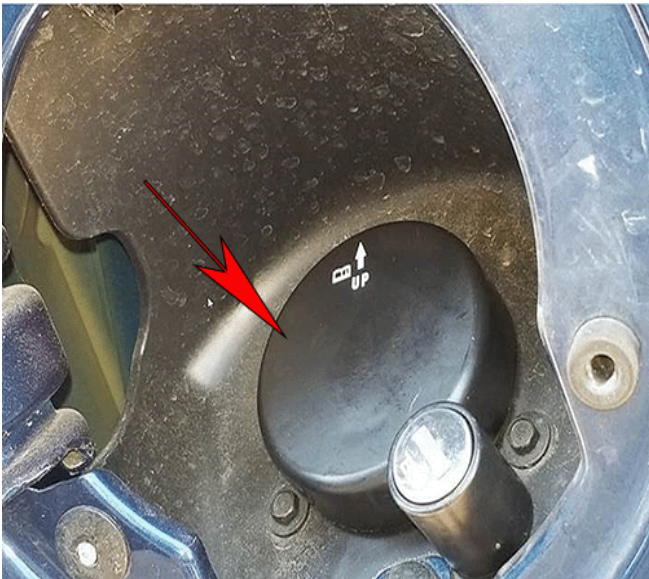
Involved Region or Country	North America and NA Export vehicles
Condition	Some customers may comment on excess amount dirt that can build up around the filler neck.
Cause	This condition may be caused when trucks are operated in high amount of dirt or dust which can migrate to the filler cap area.
Correction	<div>

</div> <p>4869504</p> <p>Notify the customer that GM accessories had made available a locking gas cap for drivers that operate in these dirty or dusty environments. This will protect the fill area from dirt intrusion and protect the fuel system.</p>
