Service Bulletin

Bulletin No.: 17-NA-307

Subject: Information On Remanufactured Engine Misfire Diagnosis After Installation

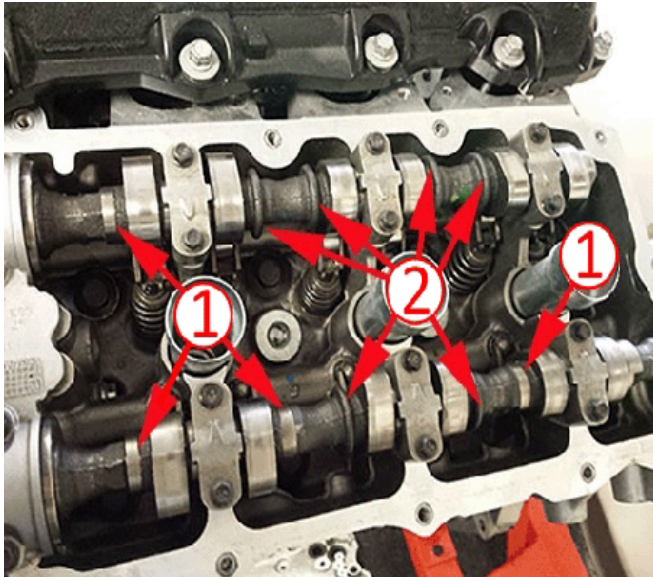
4870447

Note: Ring strategy camshaft identification is a series of rings along the camshaft that are either simply cast on the camshaft or machined down.

There are 5 rings on each camshaft.

Identification occurs by the order in which the machined or cast rings are placed on the camshaft.
