# Service Bulletin

Bulletin No.: 17-NA-308

**Subject:** Carpet Damage, Seat Mounting Stud Wear Through, Hole in Second Row (Intermediate) Carpet

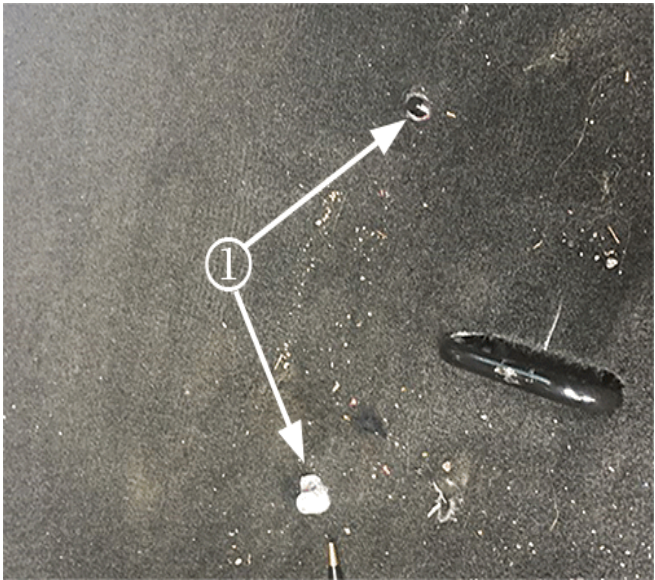
<p style="text-align: right;">4867790</p> <p>Some customers may comment that studs are wearing through (1) the second row (intermediate) carpet, around the base of the second row seats. This may be most noticeable on vehicles with second row bucket seats.</p>
<b>Cause</b>	This condition may be due to the interface design of the intermediate carpet to the seat studs, which may allow the studs to wear holes in the carpet.
<b>Correction</b>	Replace the intermediate carpet and add protective hose to the seat studs, following the steps in the Service Procedure below.
