**Subject:** Engineering Information – Malfunction Indicator Lamp (MIL) On, DTCs P0171 Fuel Trim System Lean Bank 1 and/or P0174 Fuel Trim System Lean Bank 2

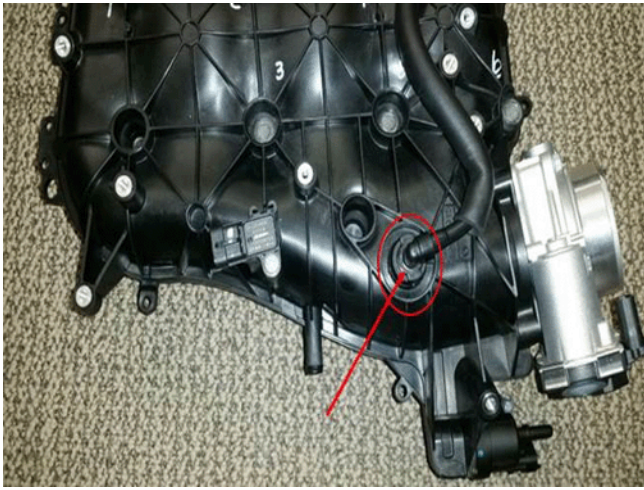
If you encounter a vehicle with the above concern, check for leak at the foul PCV tube to manifold connection as illustrated above.

- If a leak is found, contact the engineer listed below.
- If no leak is found, continue diagnosis referring to SI.
