Technical Journal

Adapter cable needed at WAM for IHU Replacement

REF NO: TJ 32995.1.1	ISSUING DEPARTMENT: Technical Service	CAR MARKET: United States and Canada		
3 US 7	PARTNER: '510 Volvo Car USA	ISSUE DATE: 2017-08-31	STATUS DATE: 2017-09-08	
FUNC GROUP: 3901	FUNC DESC: Media reader; media player	Page	1 of 6

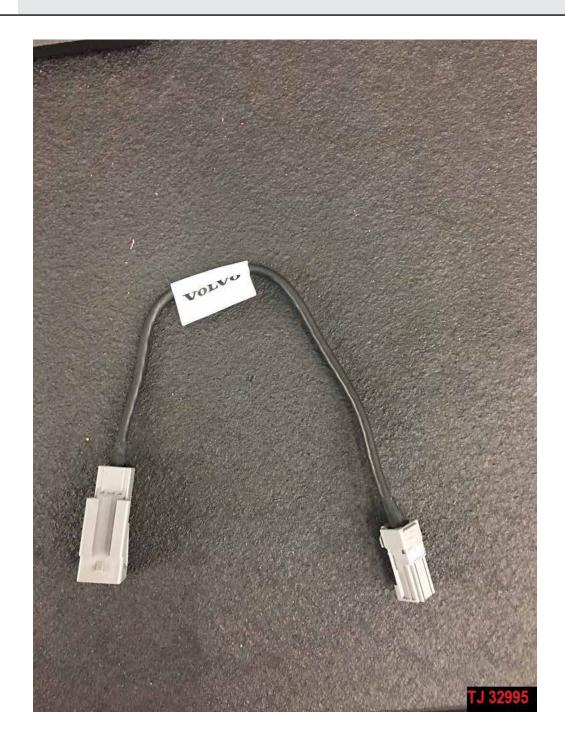
When ordering a new IHU, adapter cable part number 31680998 must also be ordered (see attachment TJ 32995 (1).JPG).

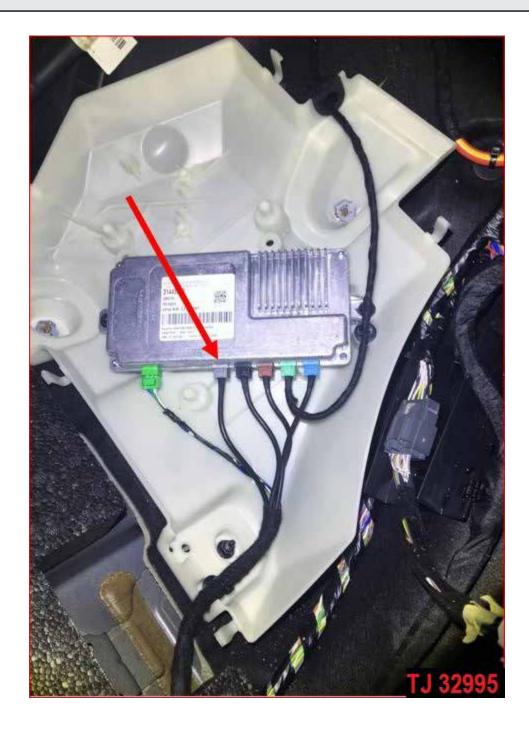
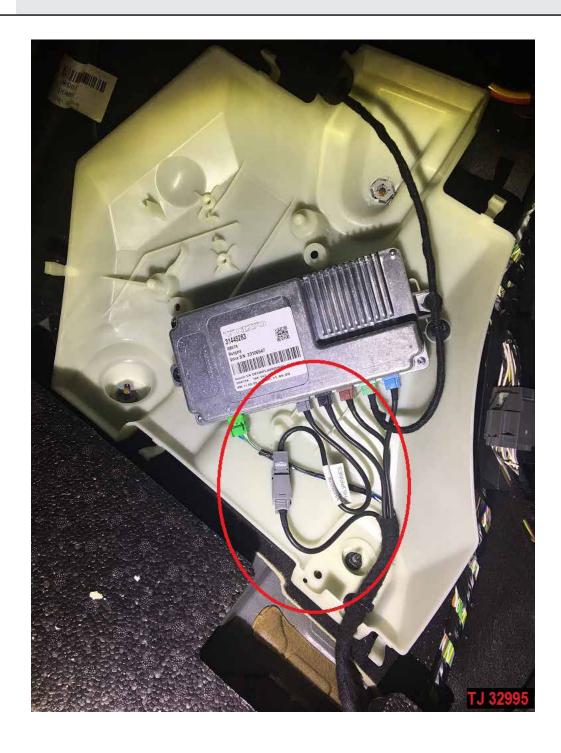
The adapter cable must be connected in-line at connector "B" at the WAM (see attachments TJ_32995 (2).JPG and TJ_32995 (3).JPG)

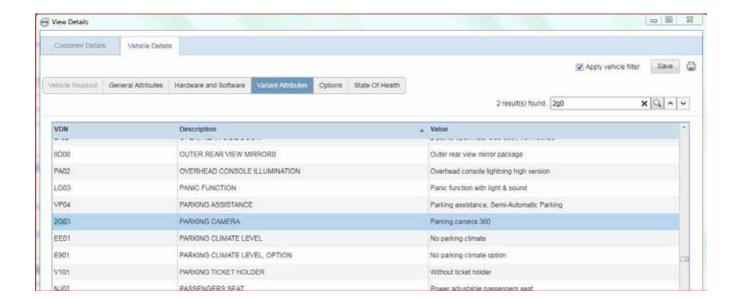
For model year 2016 XC90 with the 360 camera option (variant attribute 2G03, TJ_32995 (Variant Identifier).JPG) an extra adapter cable is needed when replacing the IHU due to a hardware change in the replacement parts.
