Technical Journal

Seats second row, outer seats, noise

REF NO: TJ 30599.3.2			ARKET: s and Canada
3 US 7	PARTNER: '510 Volvo Car USA	ISSUE DATE: 2017-01-17	STATUS DATE: 2017-01-24
FUNC GROUP: 8530	Rear seat, passenger seat.		1 of 12

Title	Rear seat, second row	Page	1 (10)
Action	Product fix	Operation number:	98641-2

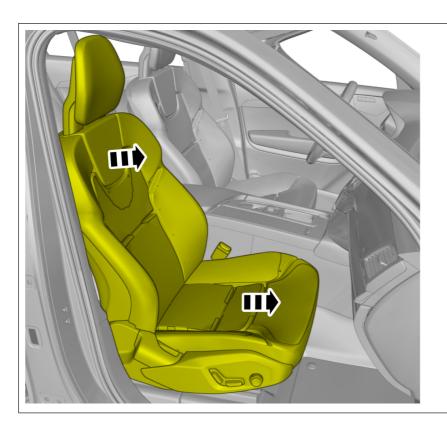
On both sides.
