# Technical Journal

**Rattling noise when closing front door**

<b>REF NO:</b> TJ 32381.1.1	<b>ISSUING DEPARTMENT:</b> Technical Service	<b>CAR MARKET:</b> United States and Canada	
<b>PARTNER:</b> 3 US 7510 Volvo Car USA		<b>ISSUE DATE:</b> 2017-03-20	<b>STATUS DATE:</b> 2017-03-23
<b>FUNC GROUP:</b> 8311	<b>FUNC DESC:</b> Side door, complete	Page 1 of 3

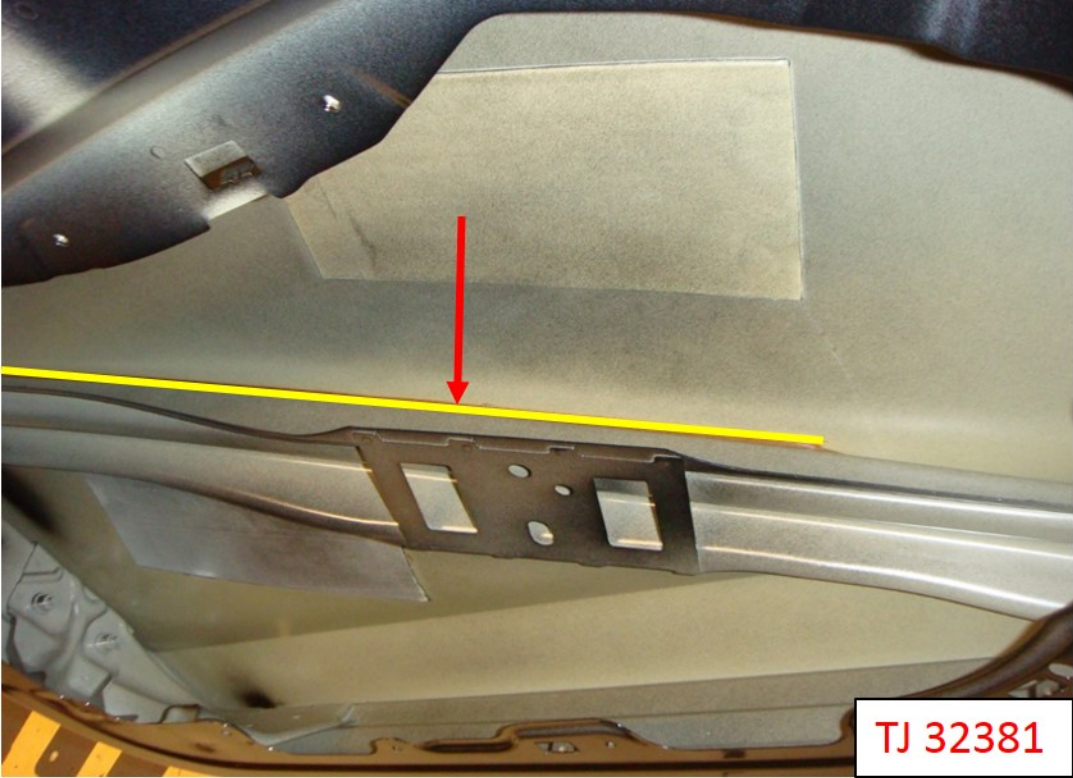
TJ 32381

When closing the front or rear door a rattle noise may occur from the middle of the outer door panel.

Apply new sealing compound ~20-30 cm (8 to 11 inches) on top of the original glue on the upper part of the beam, so that you get contact between the beam and the outer door panel.

Do not push the outer door panel when applying the glue, see attached picture TJ32381.jpg. Diameter of the glue: Ø8 mm.
