Technical Journal

Oil leakage from plug in VVT pulley

REF NO:
TJ 29131.6.0

TJ Instruction VCC-475358-1

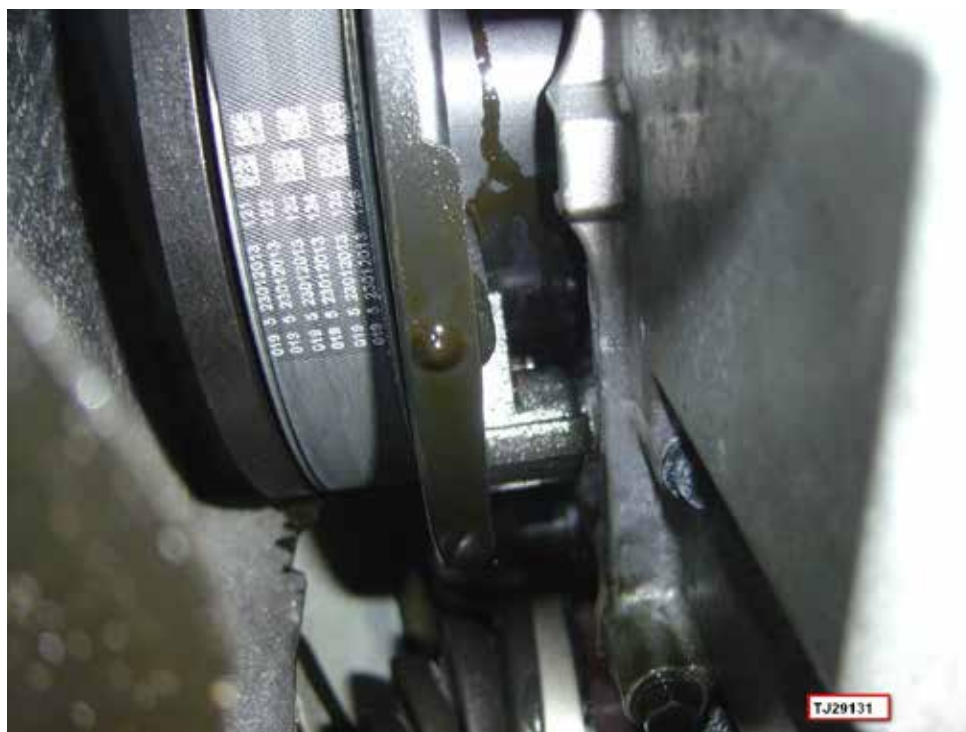
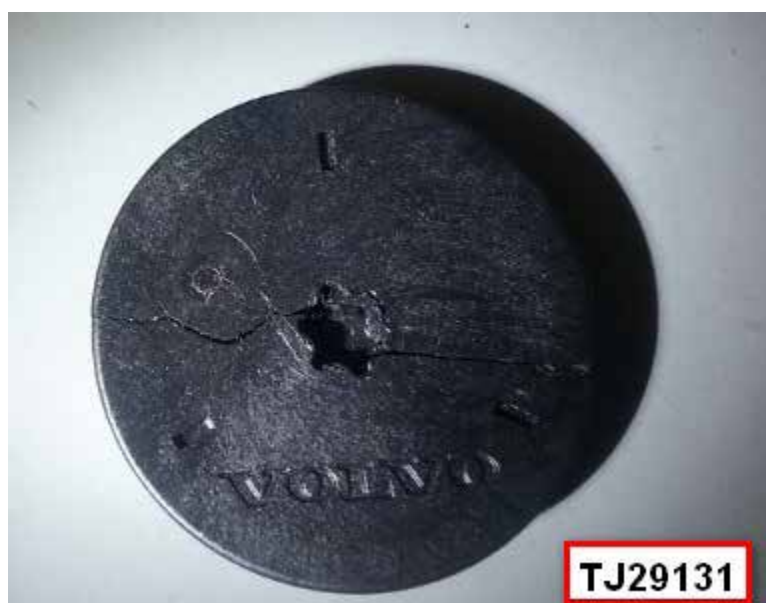
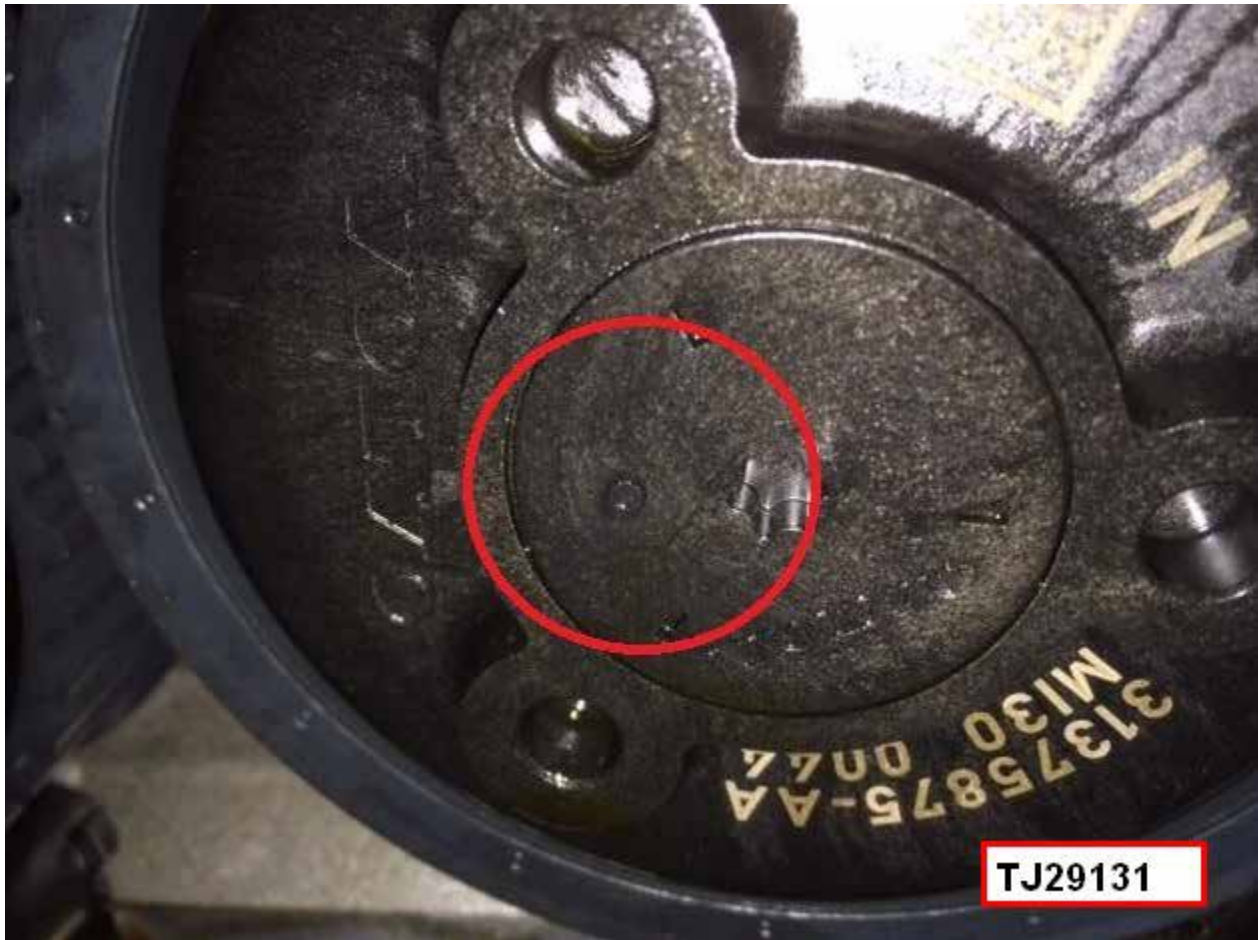
Customer may experience a low oil level warning in DIM and /or oil leakage from the engine.

The oil may leak due to a crack in the plug from the VVT pulley (see attached photo).

Replace both plugs in both VVT-pulleys according to the attached instruction. Plug PN:31375877

If the timing belt is effected with oil, replace the timing belt according to VIDA instructions.

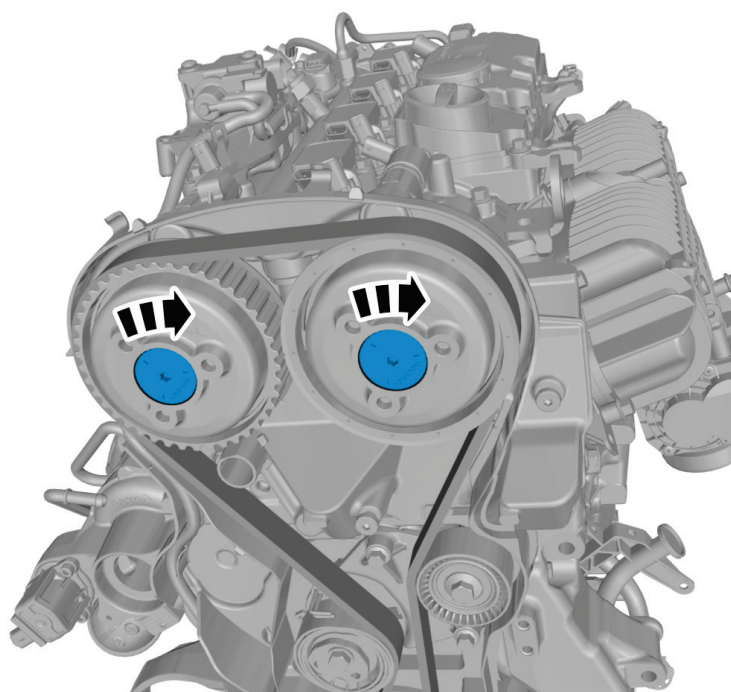
Warning! Be prepared to collect escaping fluid.

Torque:
Plug VVT unit , 5 Nm
