Technical Journal

Oil leakage from plug in VVT pulley

REF NO: TJ 29131.5.0	ISSUING DEPARTMENT: Technical Service	CAR MARKET: United States and Canada	
PARTNER: 3 US 7510 Volvo Car USA		ISSUE DATE: 2017-01-23	STATUS DATE: 2017-01-27
FUNC GROUP: 2150	FUNC DESC: Transmission	Page 1 of 8

TJ Instruction VCC-475358-1

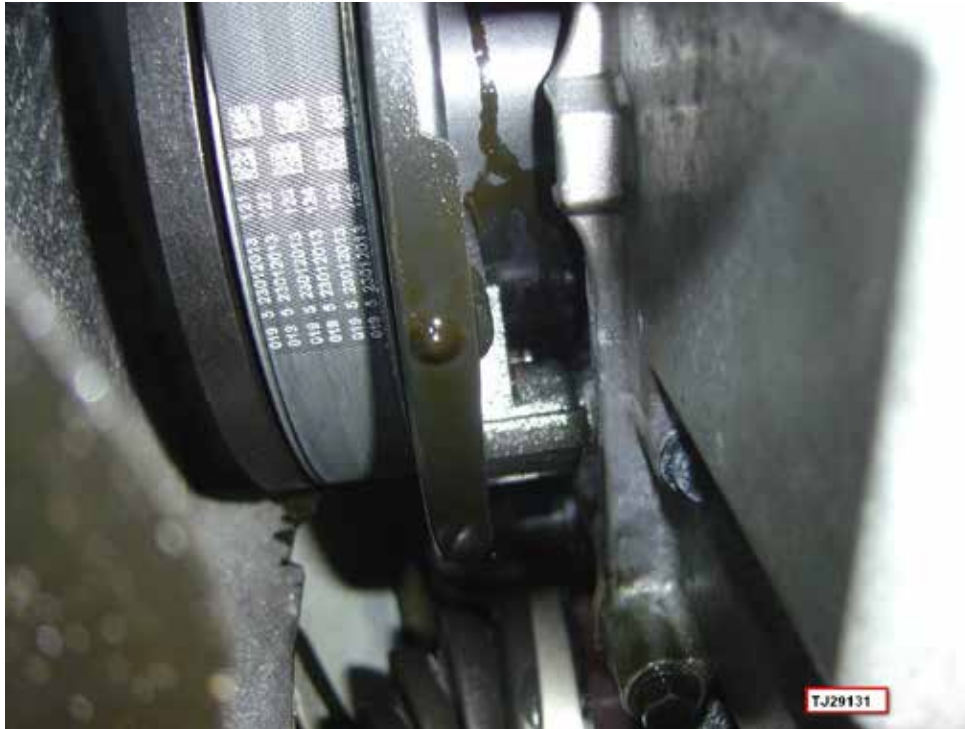
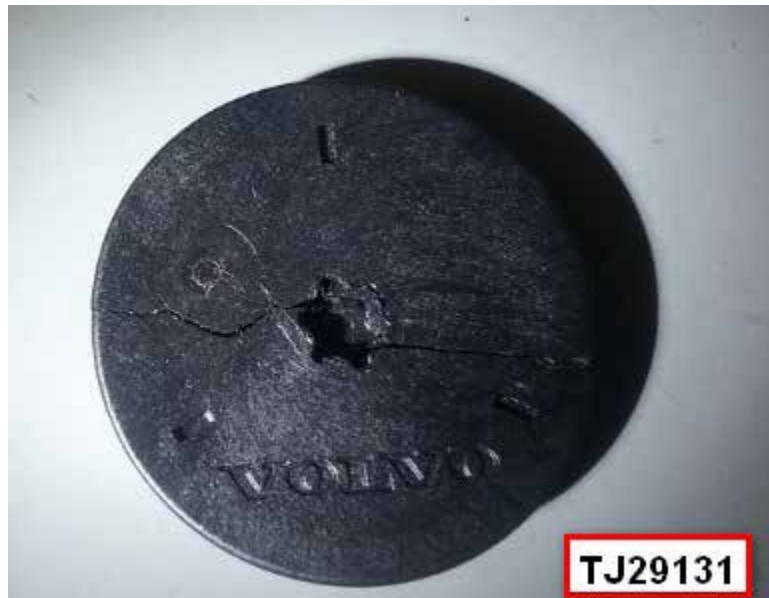
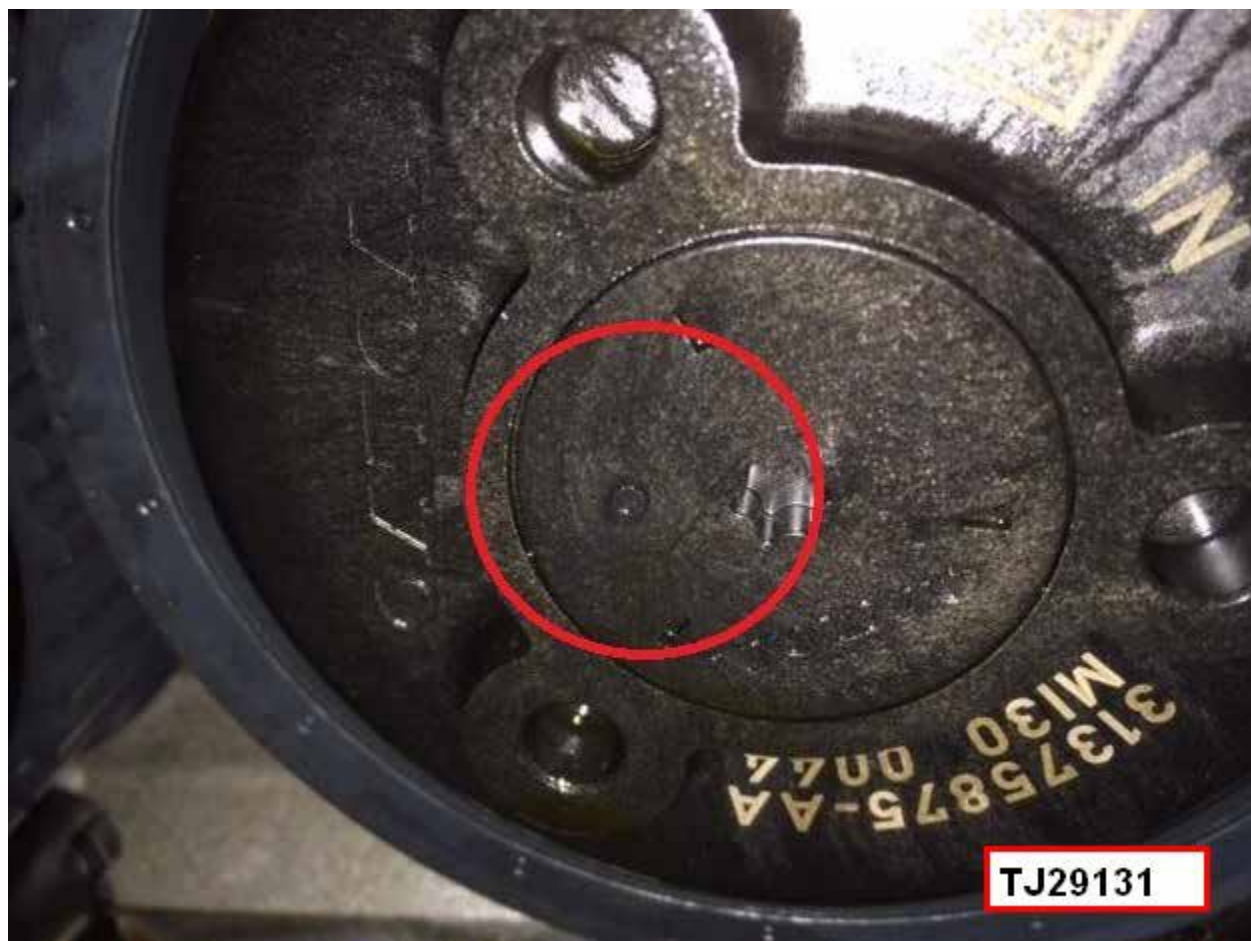
Customer may experience a low oil level warning in DIM and /or oil leakage from the engine. The oil may leak due to a crack in the plug from the VVT pulley (see attached photo).

Replace both plugs in both VVT-pulleys according to the attached instruction. Plug PN:31375877
If the timing belt is effected with oil, replace the timing belt according to VIDA instructions.
