Technical Journal

DEM-P188918 and AWD disabled message in DIM

REF NO:
TJ 31292.1.1

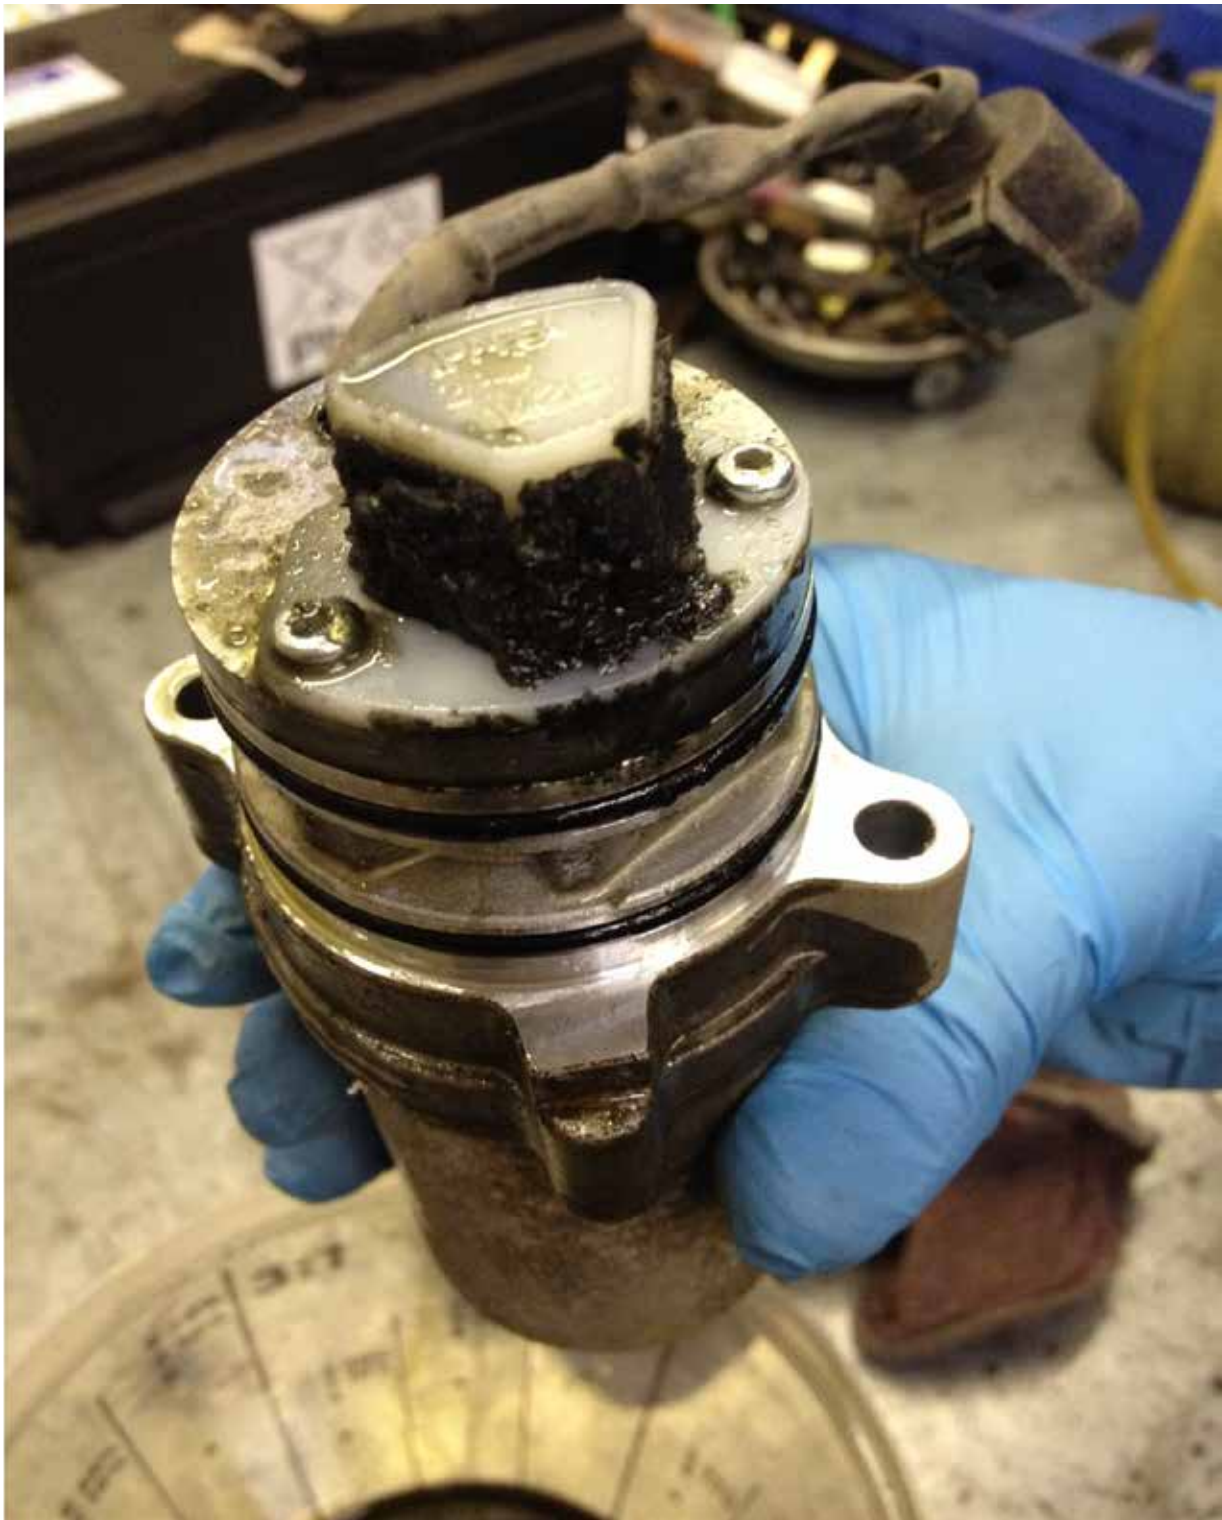
TJ 31292

1. Remove oil pump from AOC (Active On demand Coupling) and inspect the strainer. (See att.)
2. Clean strainer with lint-free cloth, **do not use any cleaning liquids** (this can contaminate the oil).
3. Clean pump sump in AOC, **do not use any cleaning liquids** (this can contaminate the oil).
4. Assemble cleaned pump to AOC.
5. Fill up with new **oil** to correct oil level in AOC according to VIDA.
6. Perform a calibration using VIDA.

If there is a screeching noise (see attachment) **and** the calibration finishes within one minute, the AOC is OK, and sludge on the strainer and/or air in the oil system is root cause. Release the car.
