# Technical Journal

**Rear door, water intrusion**REF NO:  
**TJ 31542.1.3**ISSUING DEPARTMENT:  
**Technical Service**CAR MARKET:  
**United States and Canada**PARTNER:  
**3 US 7510 Volvo Car USA**ISSUE DATE:  
**2017-02-21**STATUS DATE:  
**2017-02-28**FUNC GROUP:  
**8400**FUNC DESC:  
**Outside trim parts, glass,  
sealing mould**

TJ 31542

<b>Title</b>	Weatherstrip, door window, rear	<b>Page</b>	1 ( 5 )
<b>Action</b>	Adjustment	<b>Operation number:</b>	98630-2

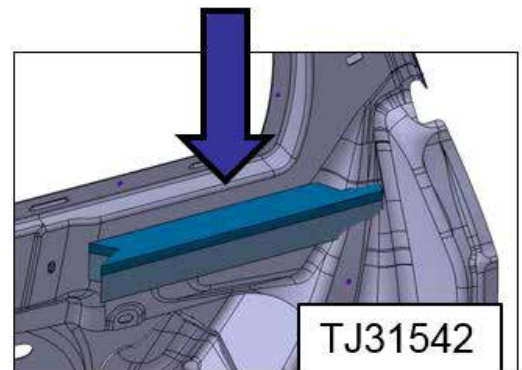
Water may accumulate on the rear door sill. Water may come out of the lower edge of the rear doors when opening the rear doors.

If it's still leaking, it's recommended to inspect the foam piece inside the door so its installed correctly according to attached picture. (see VIDA for Q glass removal).

\* If there is a complaint of water accumulation on the rear door sill, follow the attached service instructions and verify if problem is solved.
