Technical Journal

New Remote Controls and Shells for XC90/S90

REF NO:
TJ 30794.1.0

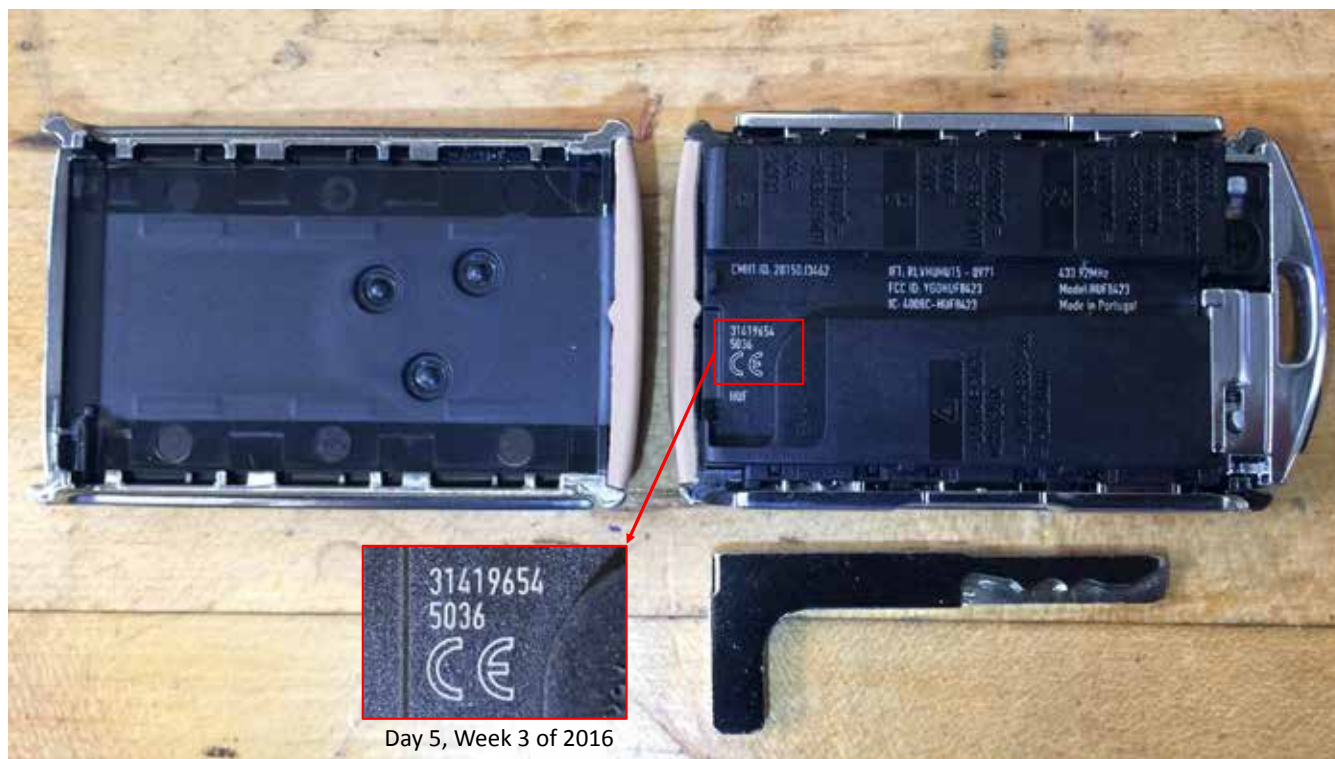
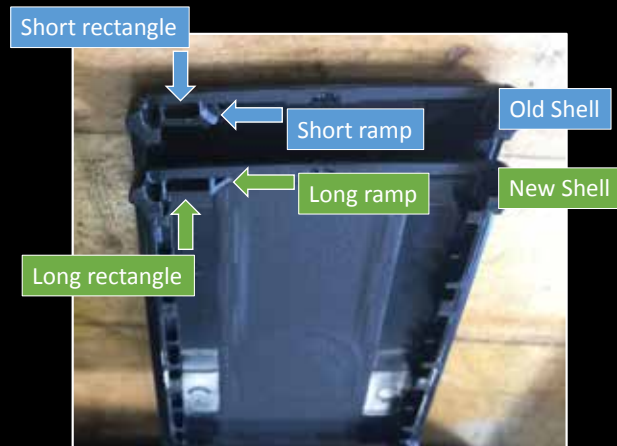
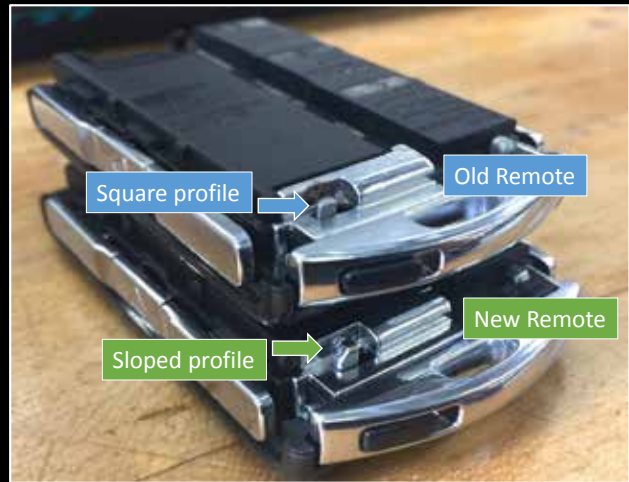
The remote control shell fastening concept has been changed to solve issues with the shells coming loose.

Remote controls and shells of the new design are not compatible with remote controls and shells of old design, and vice versa.

There are physical differences in the parts.

Identifying which design a remote control has can also be done by checking the 4-digit date code.

Remotes produced from Day 1, Week 49, Year 2016 (Date code 1496) are of the new design.

If a remote control or shell of the old design is replaced with a new part of the new design, then both the remote control and shell needs to be changed to the new design.
