TITLE:
Creaking noise from Steering Wheel Module

REF NO: TJ 32198.3.0	ISSUING DEPARTMENT: Technical Service	CAR MARKET: United States and Canada	
PARTNER: 3 US 7510 Volvo Car USA		ISSUE DATE: 2017-01-13	STATUS DATE: 2017-01-18
FUNC GROUP: 6415	FUNC DESC: STEER WHEEL, COLUMN, COLUMN LOCK, SHAFT	Page 1 of 3

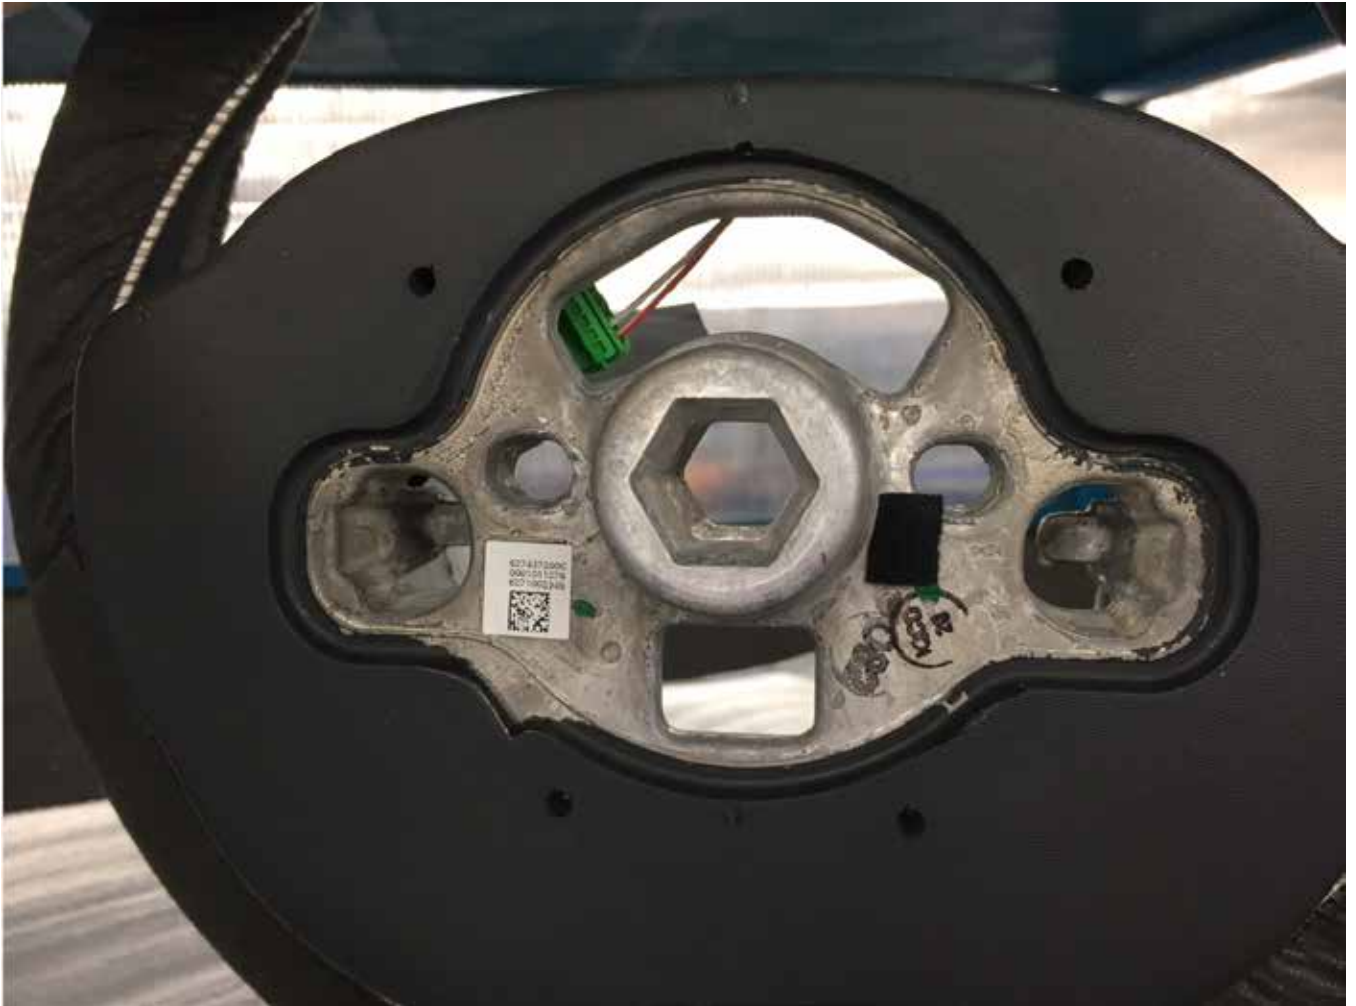
File Name	File Size
TJ 32198.PNG	2.4698 MB

If creaking/ticking noise from release pin on SWM when turning the Steering wheel follow advice under Service.

* Mount Velour tape (cut off a piece 10x15mm from Part nr.1161842) on the steering wheel, according to the attachment TJ 32198.PNG
