Technical Journal

Rattling noise when closing front door

REF NO: TJ 32381.1.0	ISSUING DEPARTMENT: Technical Service	CAR MARKET: United States and Canada	
PARTNER: 3 US 7510 Volvo Car USA		ISSUE DATE: 2017-02-24	STATUS DATE: 2017-02-24
FUNC GROUP: 8311	FUNC DESC: Side door, complete	Page 1 of 3

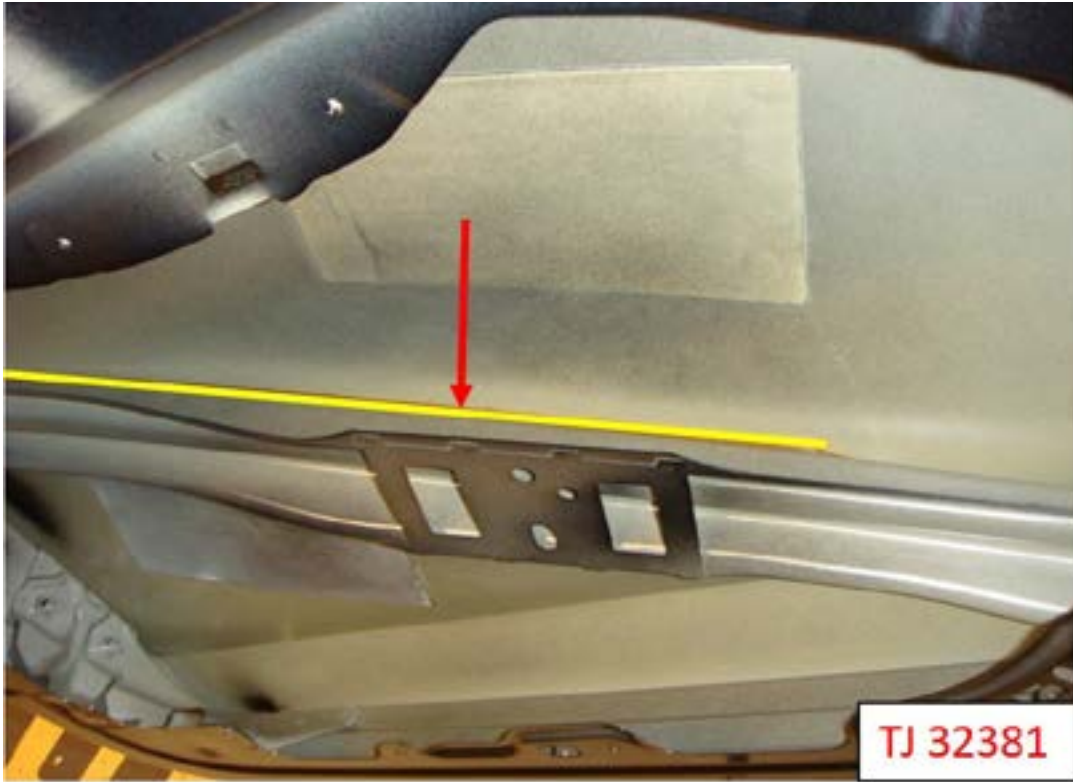
File Name	File Size
TJ32381.jpg	0.1055 MB

When closing the front or rear door a rattle noise may occur from the middle of the outer door panel.

Apply new sealing compound ~20-30 cm (8 to 11 inches) on top of the original glue on the upper part of the beam, so that you get contact between the beam and the outer door panel.

Do not push the outer door panel when applying the glue, see attached picture [TJ32381.jpg](#). Diameter of the glue: Ø8 mm.
