# Service Product Journal

**Network card Intel I219-LM causing communication problems with XC90/S90/V90**

<b>REF NO:</b> 32507	<b>ISSUING DEPARTMENT:</b> Service Operations			<b>REFERENCE BULLETINS:</b>	
<b>CATEGORY:</b>	<b>SUBCATEGORY:</b>			<b>CAR MARKET:</b> United States and Canada	
<b>Service Personnel:</b> Read and initial	<b>SERVICE MANAGER</b>	<b>SERVICE WRITER</b>	<b>WARRANTY ADMINISTRATOR</b>	<b>ISSUE DATE:</b> 2017-04-11	<b>STATUS DATE:</b> 2017-04-11
				<b>Page 1 of 3</b>

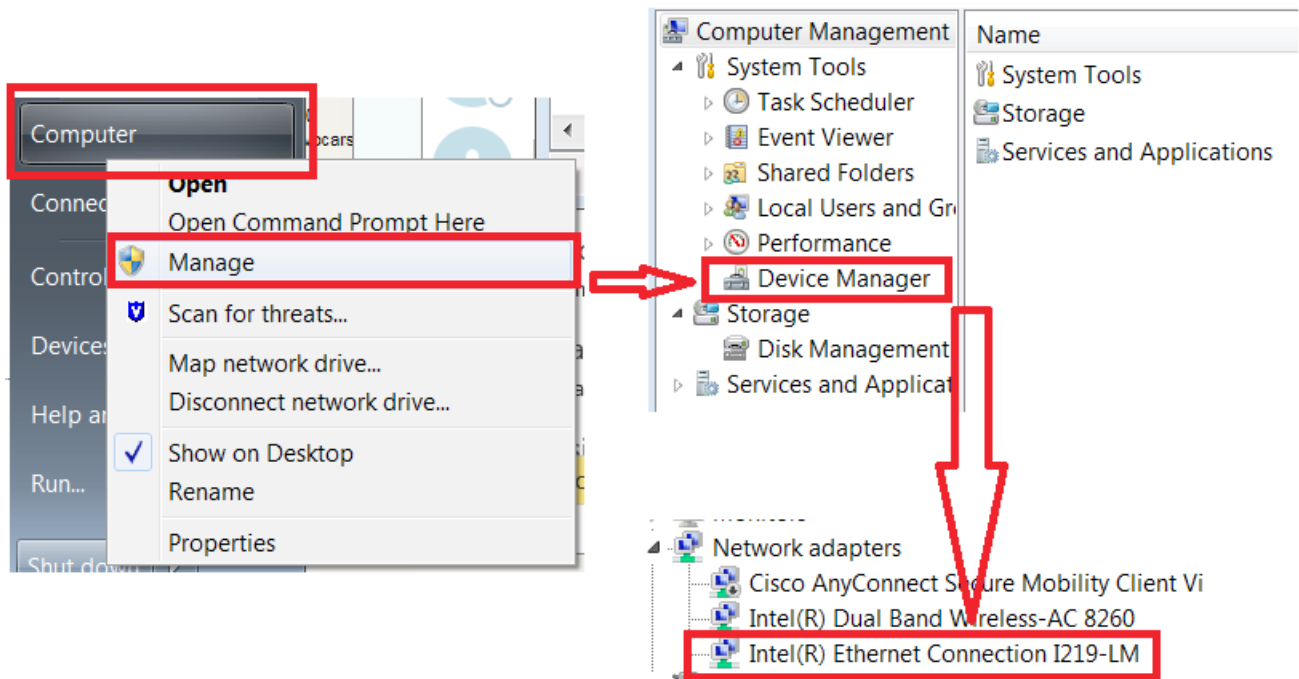
File Name	File Size
HowToCheckEthernetAdapter.png	0.0444 MB

We have verified from internal testing and also from market feedback that we have a problem sending some communication requests such as “RESET” from VIDA to vehicle on computers equipped with the **Intel I219-LM Network card**.

When VIDA sends certain requests to the vehicle, the network card will stop communicating.

Instead of connecting to the car using the network card, use a USB to Ethernet adapter instead.

We have verified several times that upgrading from Windows 7 to Windows 10 can also solve this problem.
