To: All U.S. and Canadian Volvo Retailers  
Subject: Service Action S89833

Volvo Car USA LLC and Volvo Car of Canada Ltd (Volvo) on behalf of Volvo Car Corporation, has decided to launch Service Campaign S89833 on certain model year 2017 S90 vehicles.

**SERVICE ACTION S89833 Replace Headliner Clip**

<b>Title</b>	Replace headliner clip	<b>Page</b>	1 ( 3 )
<b>Action</b>	Service action	<b>Operation number:</b>	97186-2

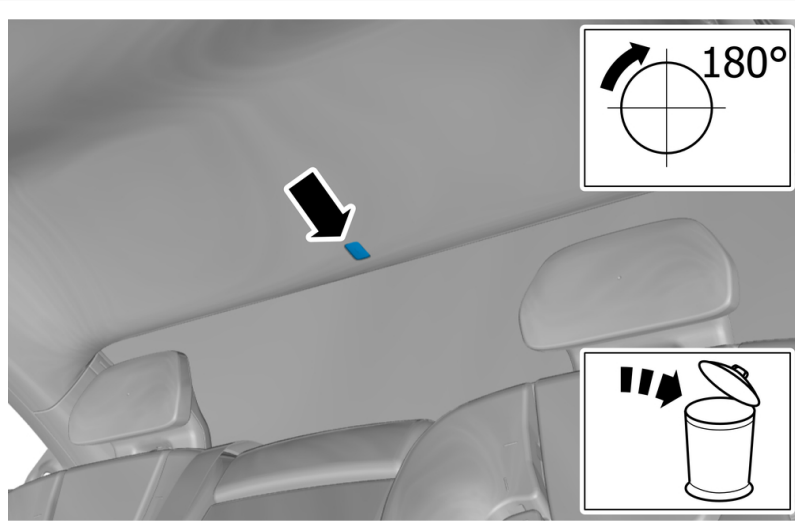
Remove the marked part.
