Technical Journal

Side door rear, water intrusion

REF NO: TJ 31542.7.0	ISSUING DEPARTMENT: Technical Service	CAR MARKET: United States and Canada	
PARTNER: 3 US 7510 Volvo Car USA		ISSUE DATE: 2017-04-28	STATUS DATE: 2017-04-28
FUNC GROUP: 8400	FUNC DESC: Outside trim parts, glass, sealing mould	Page 1 of 10

Title	Weatherstrip, door window, rear	Page	1 (5)
Action	Adjustment	Operation number:	98630-2

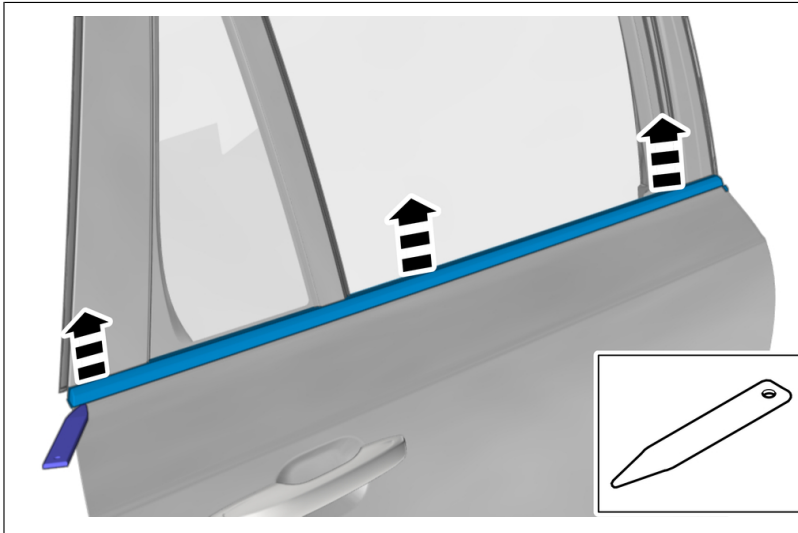
Caution! Make sure that the component is not bent.

Remove the marked part.
On both sides.

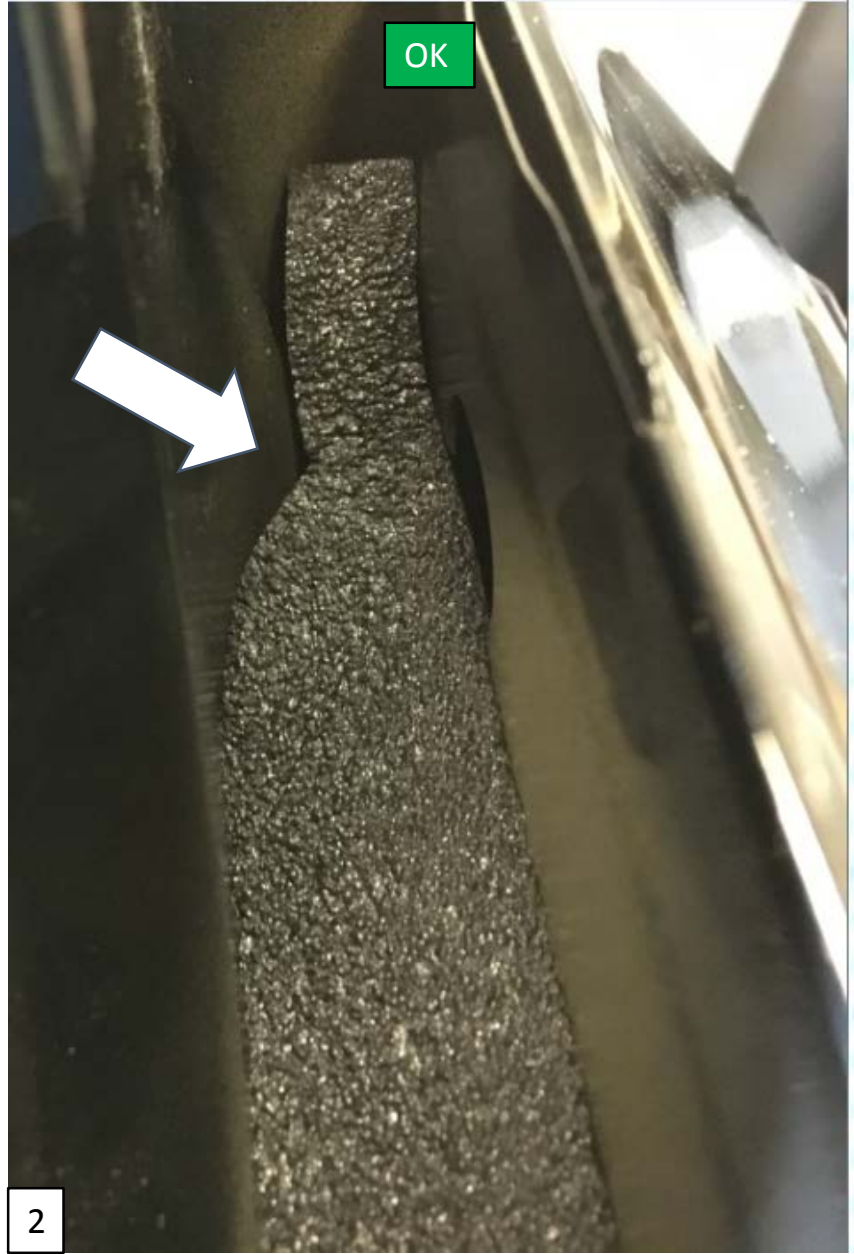
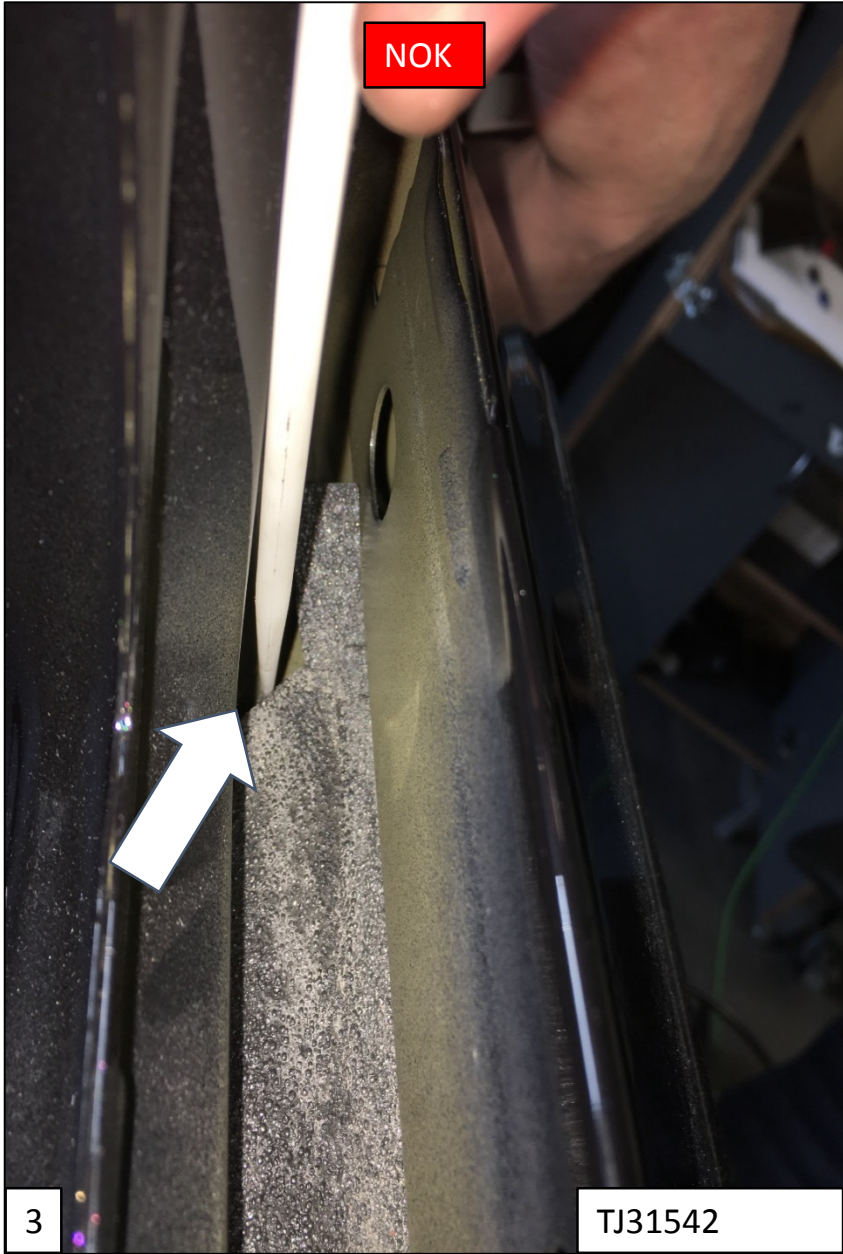
TJ31542

Water may accumulate on the rear door sill. Water may come out of the lower edge of the rear doors when opening the rear doors.

If it's still leaking, it's recommended to inspect the foam piece inside the door so its installed correctly according to attached picture. (see VIDA for Q glass removal).
