## SERVICE INFORMATION BULLETIN

**TITLE:** McLaren P1™ Exhaust Muffler Bracket Replacement

**DOCUMENT NUMBER:** 12 H 001

**AFFECTED VEHICLES:** McLaren P1™

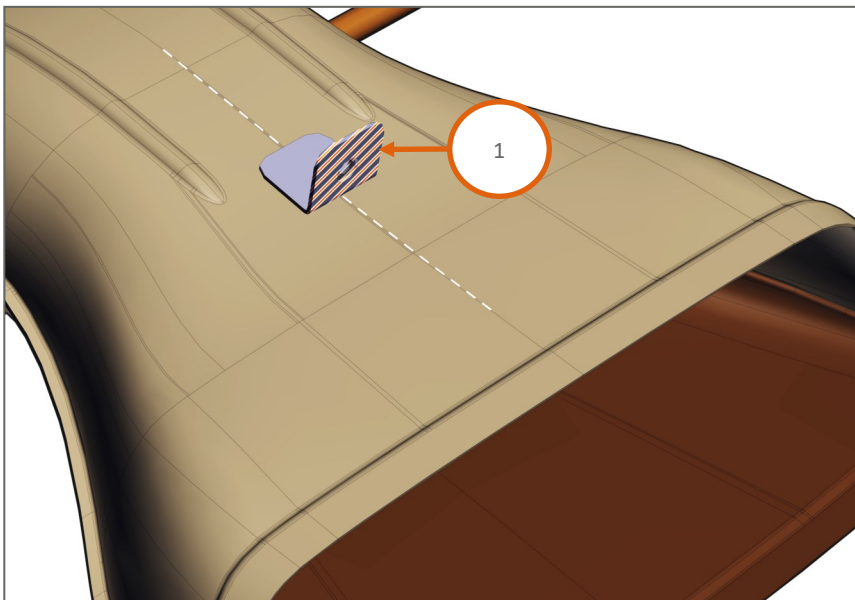
4. In this scenario the vertical section (1) of the bracket is detached from the rest of the bracket. This section is still attached to the muffler and has to be removed and scrapped. Use an Angle Grinder to flatten the edge off the horizontal section (2) of the bracket. Once this is completed proceed to Step 6.

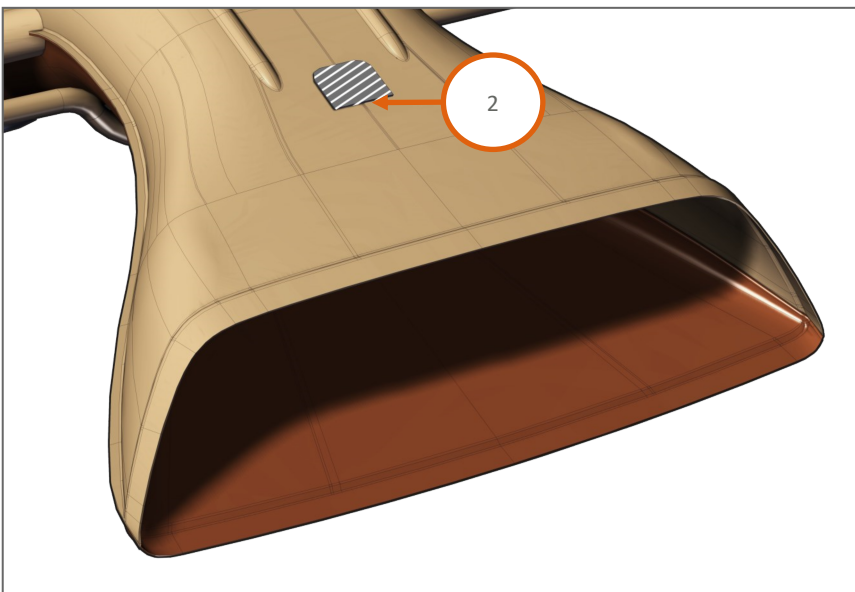
5. In this scenario the complete bracket is intact. First use an Angle Grinder with a cutting disc to cut and remove the vertical section (1). Then use a Angle Grinder to flatten the cut section (2). Once this is completed proceed to Step 6.
