HS Edition Software Update

| Bulletin Type: | Service Campaign Bulletin |
| Reference number: | 11 M 101 |
| Affected vehicles: | HS Edition |

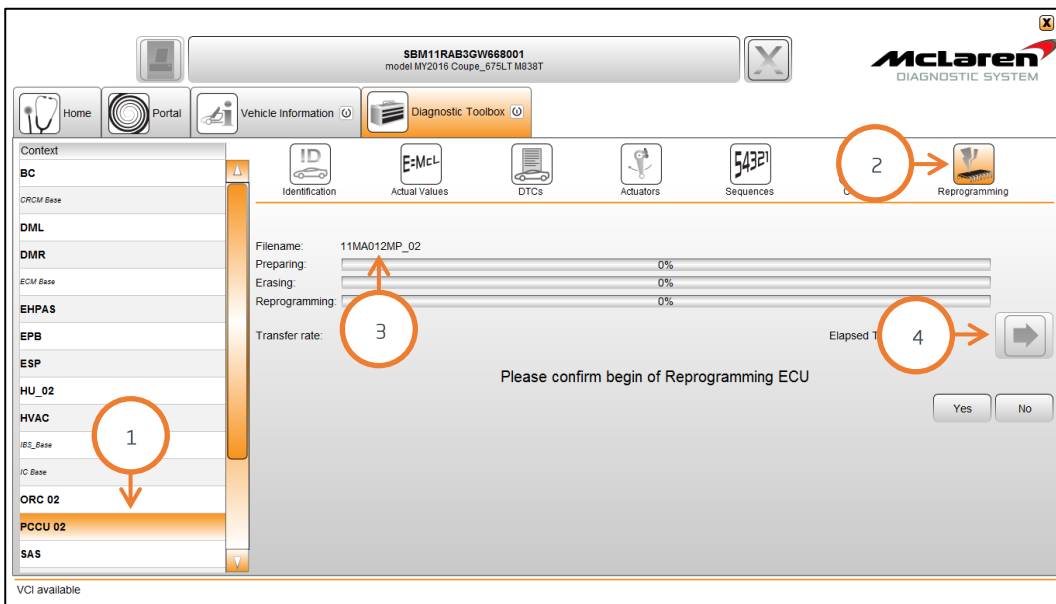
PCCU software update steps

Select PCCU 02 (1), then Reprogramming (2), the software level 11MA012MP_02 will be displayed (3). Proceed to the software update by selecting the arrow button (4).

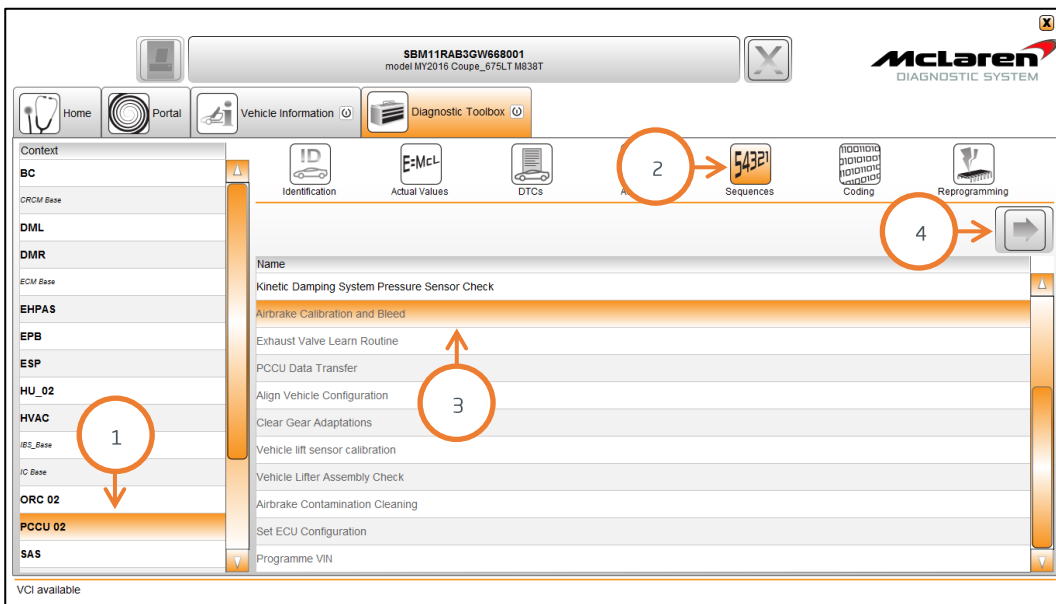
Post software update steps

Select PCCU 02 (1), then Sequences (2), then Airbrake Calibration and Bleed (3). Proceed to the operation by selecting the arrow button (4).
