# Service Bulletin

## UL2 Mechanical Suspension

### Air Tank Failures

January 2017

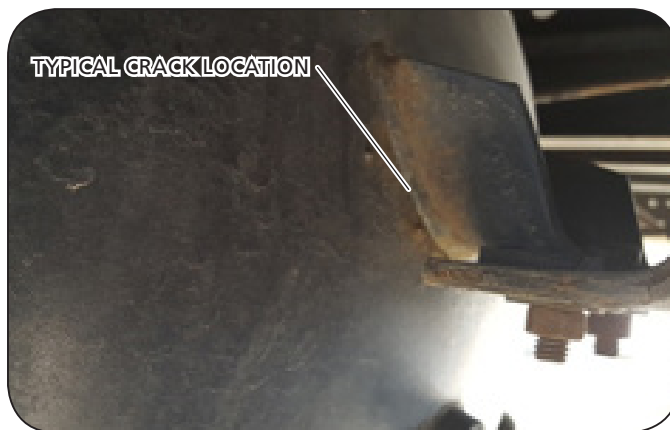
**Figure 1**

Due to premature air tank failures as a result of a crack in the tank just below the tank bracket (**Figure 1**) SAF-HOLLAND® is offering the following product enhancement to alleviate the issue. Trailers exhibiting these failures are Wabash built van trailers with SAF-HOLLAND 8" Ultra Lite 2 suspensions built in 2011 through 2016.

For affected trailers, SAF-HOLLAND will provide, at no charge, an enhancement replacement kit and 1 hour of labor per trailer at your standard shop rate. The replacement fastener kit is part number SPK0125. This program will expire on December 31, 2017. If you believe you have been affected by this you can obtain these kits by completing the service report at this link:
