Release 2

AHI NOZZLE REPLACEMENT

Prevost vehicles

On the vehicles affected by this bulletin, replace the AHI dozer by an improved part preventing nozzle clogging.

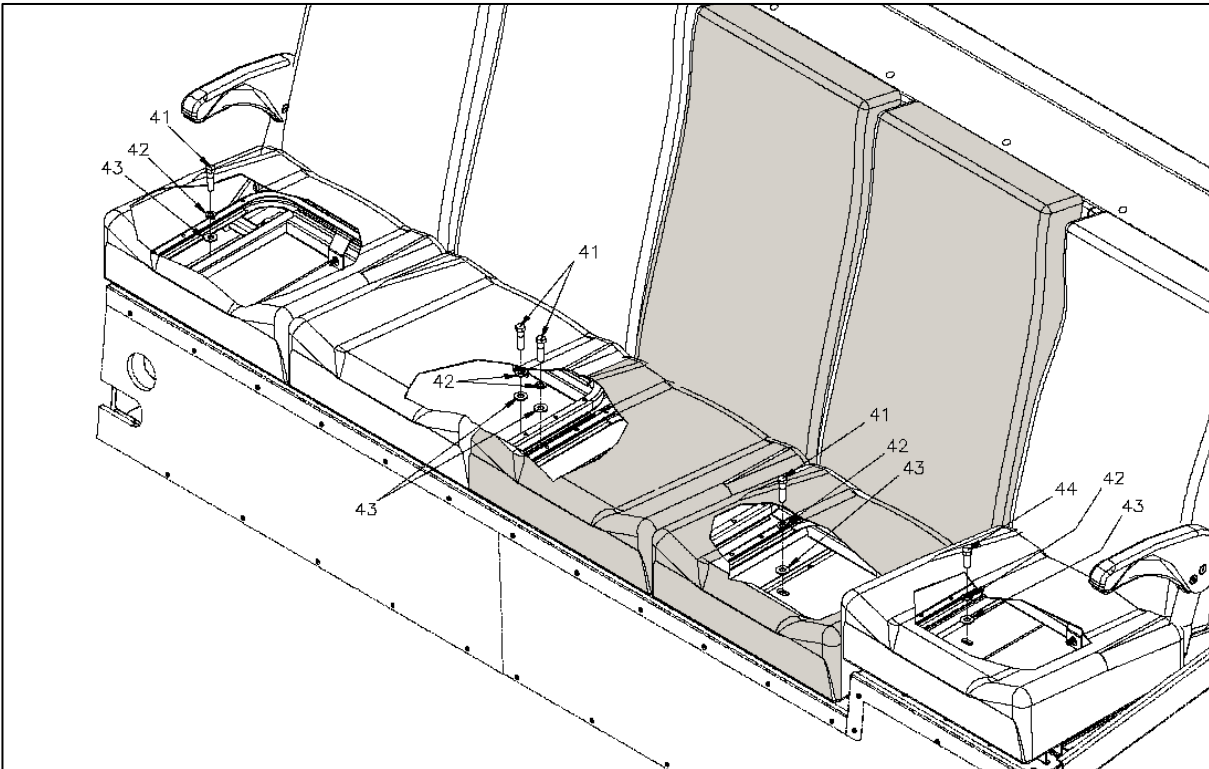
Figure 1: Seats to be removed

1. From inside the vehicle locate the rear cross seat, and remove the mid seat and the seat next to it, road side. (Fig. 1)

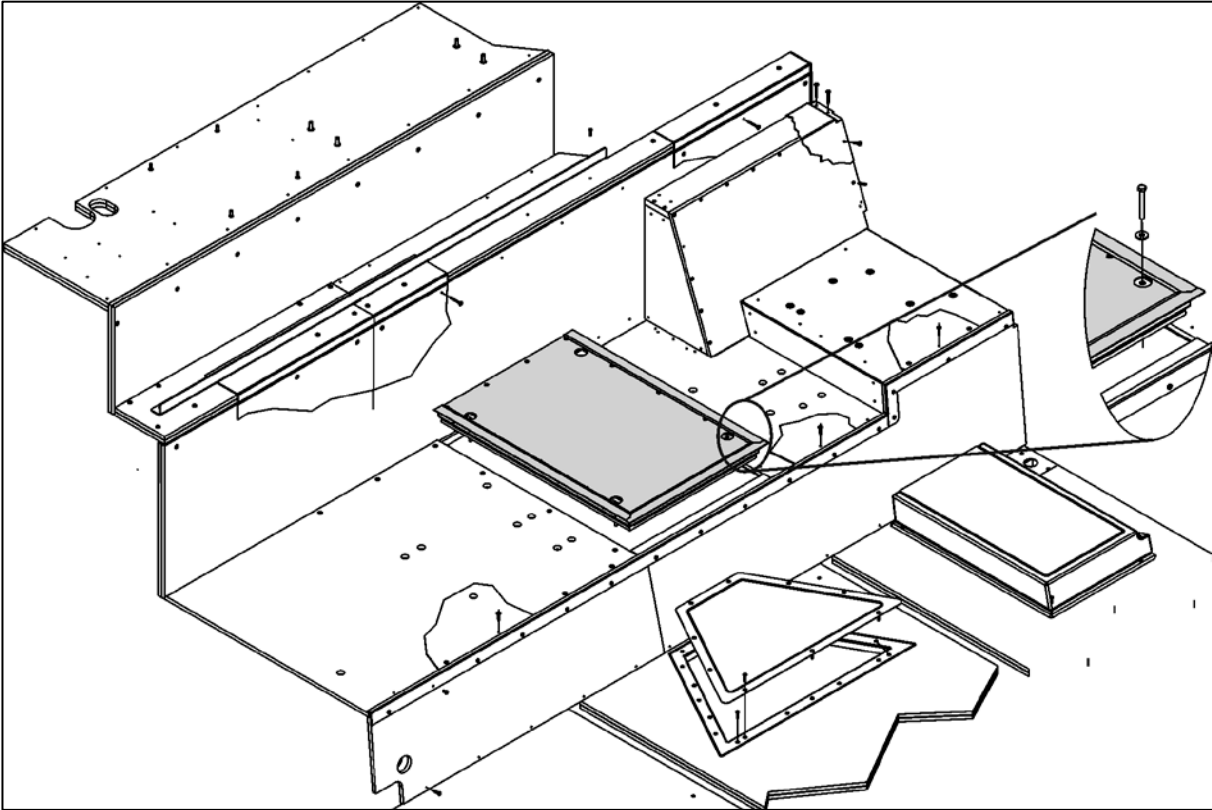
Figure 2: Engine access hatch

2. Store the removed seats away from the work area and protect the upholstery.
3. Remove the access hatch. (Fig. 2) Store access hatch and fasteners in a secure location

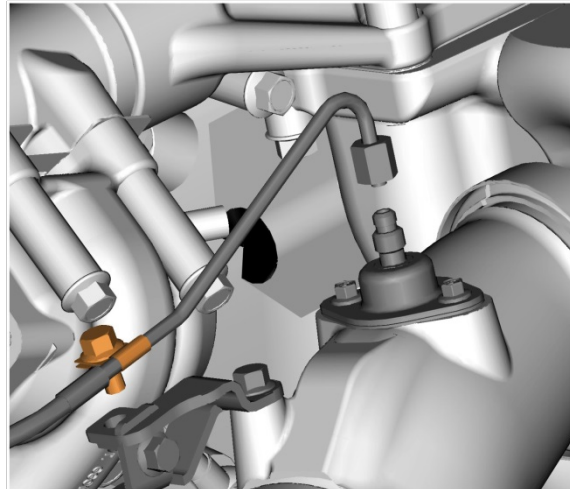
Figure 4: P-clamp & fastener

- Remove the fastener and P-clamp securing the line to the mounting bracket on the diffuser pipe.

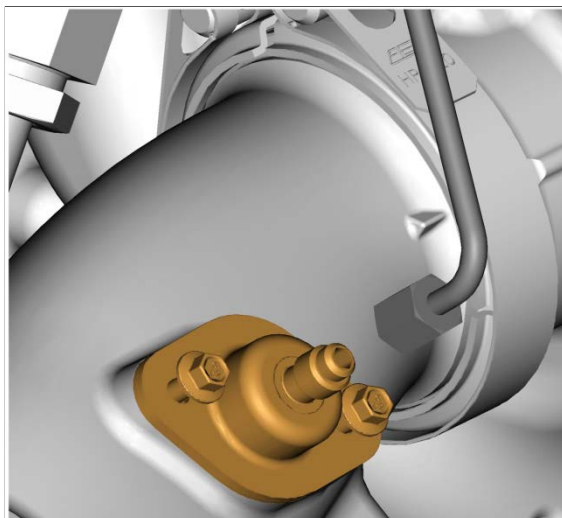
**Figure 5: Dozer**

7. Loosen the aftertreatment hydrocarbon dozer mounting fasteners. Remove the aftertreatment hydrocarbon dozer from the diffuser pipe (which attaches to the turbocharger outlet).
8. Clean the sealing surface on the diffuser pipe before mounting the aftertreatment hydrocarbon dozer.
9. Install a new gasket and aftertreatment hydrocarbon dozer onto the diffuser pipe.

Tighten to **125 ± 4.5 in-lb**

**Note:** The fasteners include pre-applied high-temperature anti-seize compound.

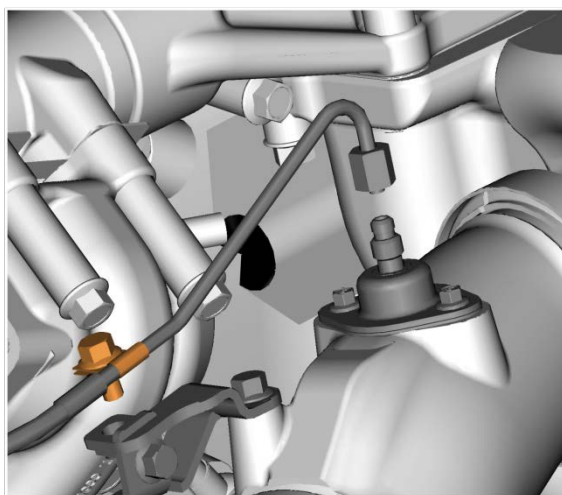
**Figure 6: P-clamp & fastener**

11. Install the P-clamp and fastener to secure the line to the mounting bracket on the diffuser pipe.
