<b>Subject:</b>  <b>CHECK ENGINE LIGHT ON WITH DTC P2610 AND P2507</b>	<b>Bulletin No:</b> 01-001/17
	<b>Last Issued:</b> 01/13/2017

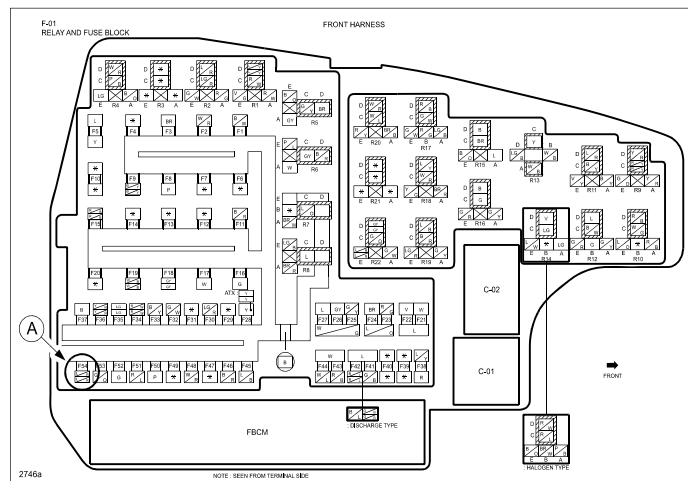
Some vehicles may experience the CHECK ENGINE LIGHT ON with DTC P2610 and P2507 stored in memory after engine start and room fuse 15A (A) removed.

- P2610:00: Instrument cluster internal engine off timer performance problem
- P2507:00: PCM battery voltage low input

1. Verify DTC P2610 and P2507 are stored in PCM memory.
2. Install ROOM fuse 15A with ignition OFF.
3. Start the engine and let it run for at least 10 seconds, then stop the engine.
4. Start the engine again and verify that the CHECK ENGINE LIGHT is not illuminated, then stop the engine.
5. Clear DTC P2610 and P2507 from PCM memory using IDS.
6. Verify no other DTCs are stored in memory. If so, troubleshoot them according to the MS3 online instructions or Workshop Manual.

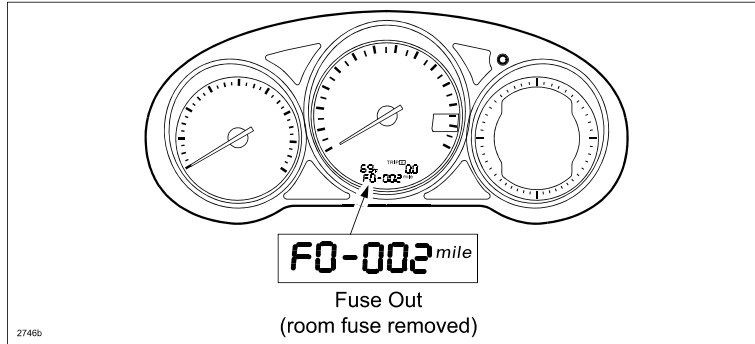
**NOTE:** The odometer will display "F0-002" during transport mode (room fuse 15A removed). Transport mode is canceled when room fuse 15A is installed or the vehicle odometer is more than 12.4mi (20km).
