# Service Bulletin Mazda North American Operations

Subject: Bulletin No: 01-003/17

2014-2016 Mazda3 vehicles with VINs starting with JM1 2014-2016 Mazda3 vehicles with VINs starting with 3MZ

**CHECK ENGINE LIGHT ON WITH P0451:00 IN COLD WEATHER**

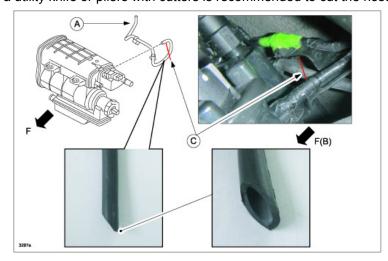
When the engine is started for the first time after parking overnight in cold weather (below freezing), some vehicles may exhibit the check engine light on with DTC P0451:00 (Fuel tank pressure sensor: sensor characteristic malfunction) stored in memory. This concern may be caused by an increase in discharge resistance due to water accumulated and frozen in the canister vent hose.

- 1. Verify the customer concern
- 2. Safely lift the vehicle up on a hoist.
- 3. Check if the Canister Vent Hose is clogged with frozen water.
  - If the hose is clogged with frozen water, go to the next step.
  - If the hose is not clogged with frozen water, refer to MS3 online instructions to diagnose DTC P0451:00.
- 4. For 4-door sedan
  - a. Cut the Evaporative Hose No.1 (A) diagonally to enlarge the cross section as shown (C = cut point) to avoid water from accumulating and freezing. (F = vehicle front, F(B) = Vehicle front (view from bottom))

**NOTE:** Use of a utility knife or pliers with cutters is recommended to cut the hose.
