<b>Subject:</b>  <b>TPMS WARNING LIGHT ON</b>	<b>Bulletin No:</b> 02-001/17
	<b>Last Issued:</b> 01/06/2017

2016-2017 CX-3 AWD vehicles with VINS lower than JM1DK\*\*\*\*\*147607 (produced before June 24, 2016)

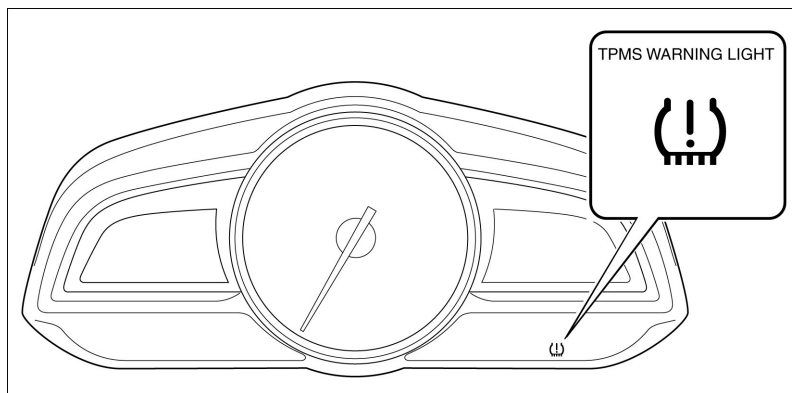
Some vehicles may experience a Tire Pressure Monitoring System (TPMS) warning light on when driving on a smooth road surface even if the TPMS system has been properly initialized at the specified tire air pressure.

The TPMS system may have been improperly initialized when the initialization was performed on certain types of rough road surfaces. Then, when driven on smooth road surfaces, the TPMS system may detect improper tire air pressure. The DSC HU/CM control logic has been changed for this concern.

1. Verify customer concern.
2. Are all four tire pressures at specification?  
**Tire Pressure Specification:** Front; 36 psi, Rear; 33 psi
  - a. Yes - Go to step 3.
  - b. No - This service bulletin does not apply.
3. Replace the DSC HU/CM. Refer to MS3 Workshop Manual online DSC HU/CM REMOVAL/INSTALLATION.  
**NOTE:** Rear brake pad replacement is necessary for proper brake system air bleeding.
4. With Mazda Modular Diagnostic System (M-MDS), perform the TPMS initialization. Refer to MS3 Workshop Manual online TIRE PRESSURE MONITORING SYSTEM INITIALIZATION PROCEDURE. This will initialize TPMS and disable the mis-use prevention logic at the same time.
5. Verify repair.
