Subject: ALUMINUM WHEEL PAINT DAMAGE (BLACK SPOT, WHITE SPOT, FLAKING, DISCOLORED, BLACKENED)	Bulletin No: 02-002/17
	Last Issued: 01/06/2017

2016 Mazda6 vehicles with VINs JM1 GJ ***** 400001 through 488592 (produced from November 25, 2014) through June 30, 2016)

2017 Mazda6 vehicles with VINs lower than JM1 GL ***** 110566 (produced before September 09, 2016)

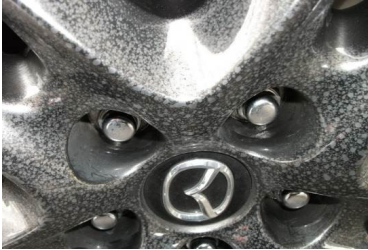
Some vehicles may exhibit the bright type aluminum wheel(s) having one of paint damage conditions shown in the sample photos below. The damage extends to the front surface of the aluminum wheel partly or entirely.

Black Spot	White Spot	Flaking

3. Replace the affected aluminum wheel(s). Refer to MS3 online Workshop Manual WHEEL BALANCE ADJUSTMENT (ALUMINUM ALLOY WHEEL).

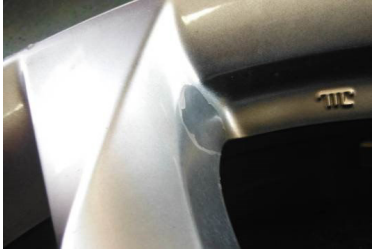
Discolored	Blackened
