Subject: KNOCKING / SQUEAKING NOISE FROM FRONT SHOCK ABSORBER, CREAKING NOISE FROM FRONT LOWER ARM BUSHING	Bulletin No: 02-003/17
	Last Issued: 01/13/2017

APPLICABLE MODEL(S)/VINS

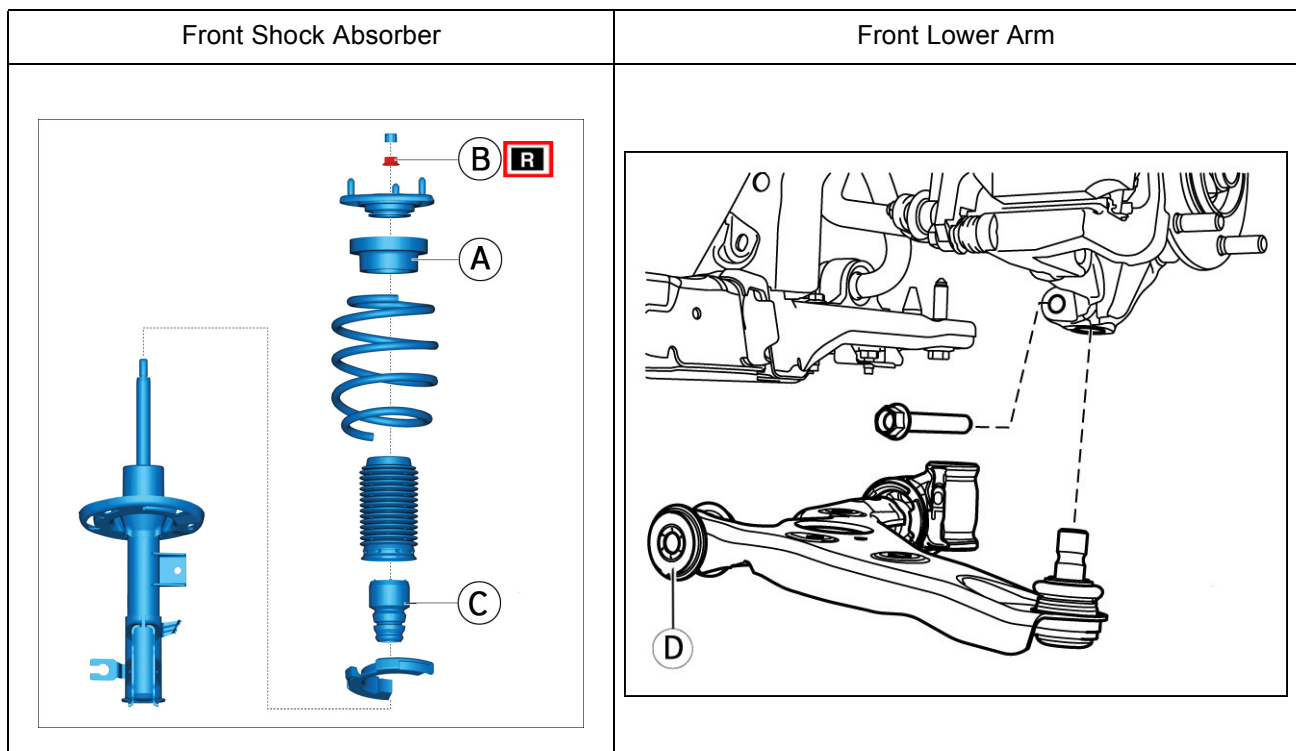
Some vehicles may exhibit a knocking / squeaking noise from the front shock absorber when driving on rough roads and/or when turning the steering wheel while the vehicle is stopped.

- upper front strut bearing (A) damage. (CX-5 and Mazda6)
- stick/slip between the front strut bearing and coil spring. (CX-3, CX-5 and Mazda6)
- the bump stopper (C) may be contacting the strut bearing when the front shock absorber is compressed, causing a popping noise. (Mazda6 only)
- The front lower arm bushing (D) is making a stick-slip noise in wet road conditions. (CX-5, Mazda6 and CX-9).

1. The material and production method of the front strut bearing (A) has been changed. (CX-5 and Mazda6)
2. A protector has been installed onto the coil spring. (CX-5 and Mazda6)
3. The shape of the bump stopper (C) will be modified in the future. (Mazda6 only)
4. The shape of the coil spring has been changed. (CX-3 only)
5. Friction of the lower arm bushing has been reduced by adding a dry coating. (CX-5, Mazda6 and CX-9).

NOTE: The piston rod nut (B) requires replacement.

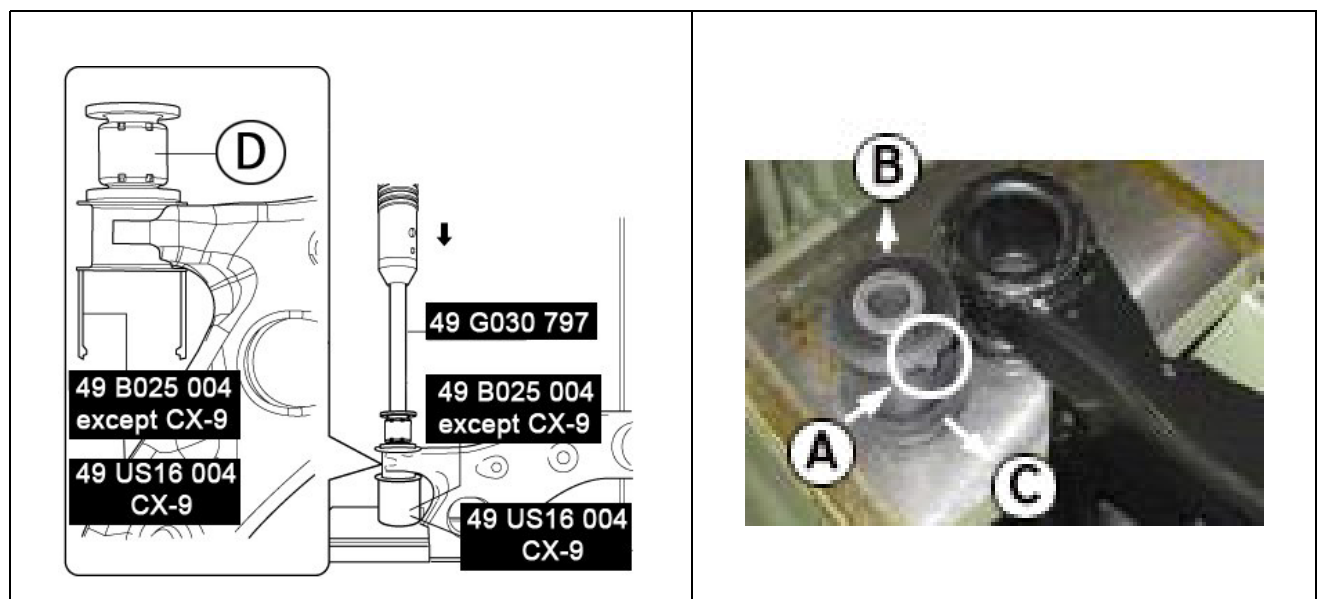
CAUTION: Make sure that the bushing has been properly inserted by checking that the tab of the bushing is completely expanded as shown in the OK illustration.

OK	NG
Tab is completely expanded	Tab is NOT completely expanded yet

3. Install the front lower arm bushing (D) using SSTs.
Install the front lower arm bushing so that the projection (A) shown in the figure is pointing toward the front (B) and out of the vehicle (C).

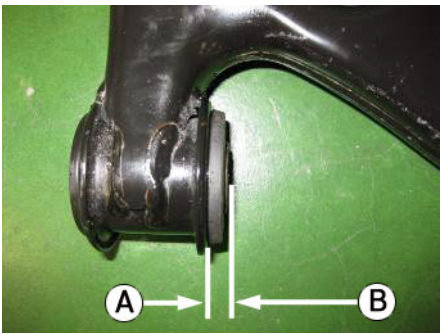
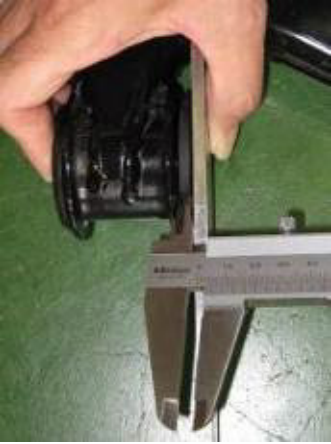
Specification: Width: **5.6 +/- 0.8mm** (0.22 +/- 0.03 in)

4. After the installation, verify that the front lower arm bushing has been installed to the correct position by the procedure shown in the figure.

Measure the distance of the lower arm end face (A) and the inner pipe bushing (B).		Measure the width as shown
