Subject: CREAKING / SQUEAKING NOISE FROM RIGHT REAR SUSPENSION	Bulletin No: 02-004/17
	Last Issued: 01/13/2017

2016 CX-9

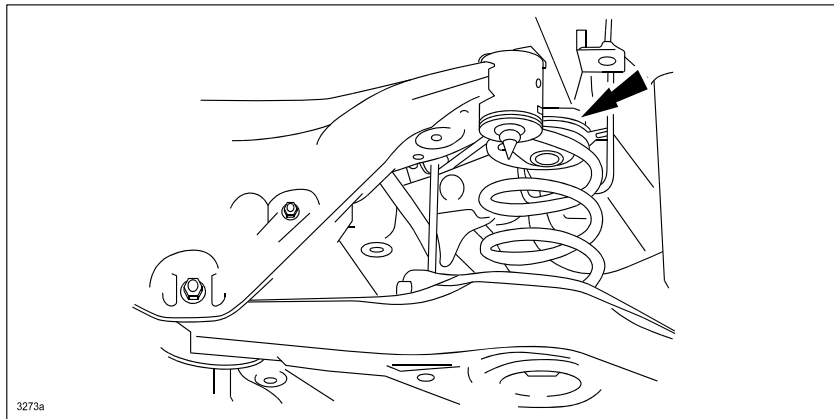
Some vehicles may experience a creaking/squeaking noise from the right rear suspension. The noise occurs while coming to a (slow speed) stop or when starting from a stop. The noise can also be duplicated by gently bouncing the right rear suspension (i.e. simulating the movement of a passenger exiting the right rear door).

The noise may be caused by a stick-slip condition between the upper spring seat rubber and the coil spring. To eliminate this concern, the shape of the coil spring has been changed.

1. Verify the customer concern.
2. Replace the right rear coil spring with a modified one according to the instructions on MS3 online (REAR COIL SPRING REMOVAL/INSTALLATION).

NOTE: If the upper spring seat rubber is found to be damaged, replace it with a new one.
