© 2017 Mazda Motor of America, Inc.

Subject: POPPING AND/OR SQUEAKING NOISE FROM FRONT SHOCK ABSORBER AND/OR CREAKING NOISE FROM FRONT LOWER ARM BUSHING	Bulletin No: 02-005/17
	Last Issued: 01/13/2017

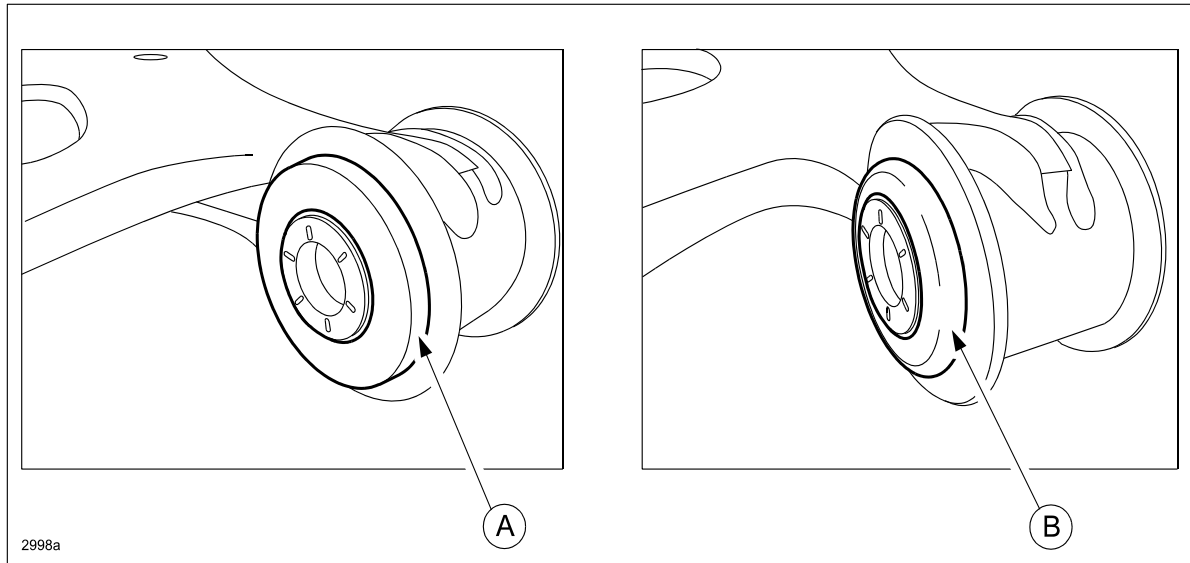
CAUTION: Make sure the bushing has been properly inserted by verifying that the bushing tab **IS FULLY EXPANDED**, as shown in the illustration to the left (A). The illustration to the right (B) shows an example of a bushing tab that **IS NOT FULLY EXPANDED**.
