Service Bulletin

Subject:
VIBRATION FELT THROUGH FLOOR / SEAT / STEERING WHEEL AT APPROX.
25 - 30 MPH

Bulletin No: 03-001/17

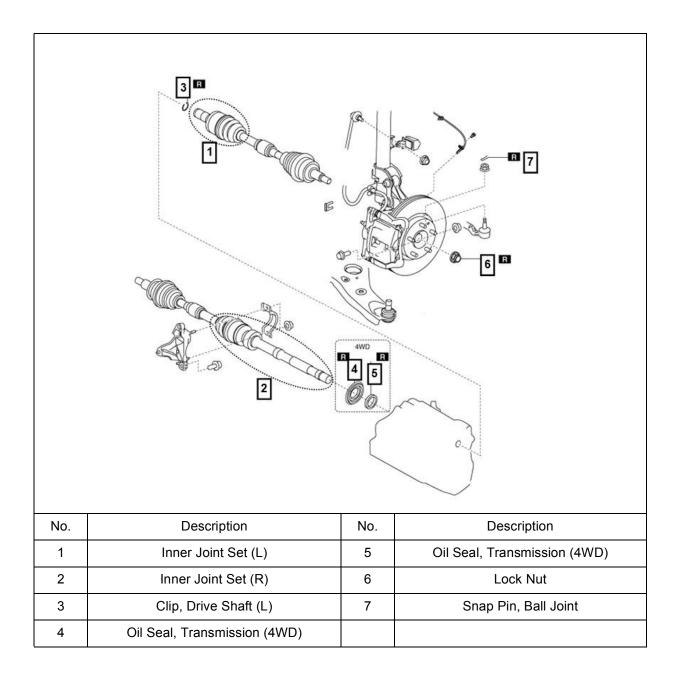
Parts Location:

The vibration may be caused by wear on the inner surface of the tripod joint case (inner side of front drive shaft). To eliminate this concern, a coating has been applied to the inner surface of the tripod joint case to improve wear resistance.

- 1. Verify the customer concern.
- 2. Replace the inner joint set for the left and right drive shafts. Refer to MS3 online Workshop Manual:
 - CX-5 FRONT DRIVE SHAFT REMOVAL/INSTALLATION and FRONT DRIVE SHAFT (TRIPOD JOINT) DISASSEMBLY/ASSEMBLY.
 - Mazda6 FRONT DRIVE SHAFT REMOVAL/INSTALLATION and FRONT DRIVE SHAFT (TRIPOD JOINT) DISASSEMBLY/ASSEMBLY.
- 3. Verify the repair.
