Subject: NO COOL AIR FROM AIR CONDITIONER (LEAK FROM EVAPORATOR)	Bulletin No: 07-002/17
	Last Issued: 01/13/2017

2013-2016 CX-5 vehicles with VINs lower than JM3KE*****802941 (produced before April 7, 2016)

2014-2016 Mazda6 vehicles with VINs lower than JM1GJ*****480633 (produced before April 7, 2016)

2014-2016 Mazda3 (Japan built) vehicles with VINs lower than JM1BM*****346088 (produced before April 7, 2016)

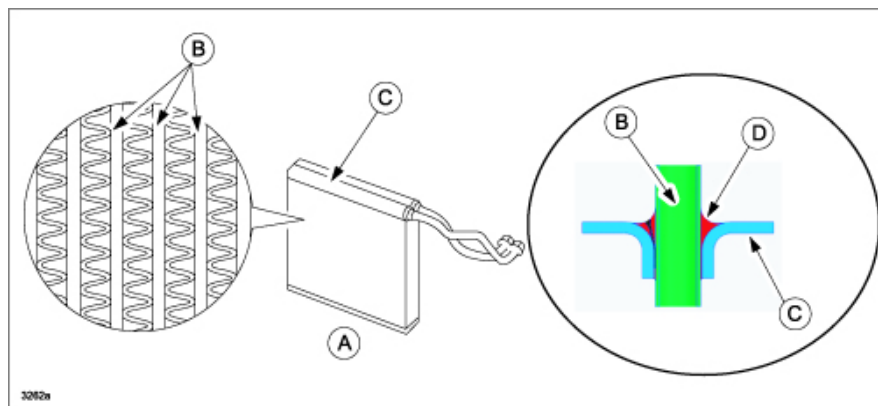
Some customers may complain about no cool air from the vents when the air conditioner (A/C) is ON. This concern may be caused by A/C refrigerant leaking from the evaporator (A) at the joint between the tubes (B) and the header (C) due to improper brazing (D). To correct the problem, the configuration of the header has been changed to improve the brazing performance in this area.

1. Verify customer concern.
2. Verify that the level of A/C refrigerant charge is low (The A/C refrigerant high and low pressures are both low).
3. Check for refrigerant leakage from any part of the system, using a colored dye.
 - If leakage is found from the A/C unit drain hose, check the A/C unit inside. If leakage is detected from the evaporator, replace it with a modified one according to the instructions on MS3 online (A/C UNIT DISASSEMBLY/ASSEMBLY).

NOTE: When replacing the evaporator, add approximately 40 ml {40 cc, 1.4 fl oz} of compressor oil according to the instructions on MS3 online (A/C COMPRESSOR REMOVAL/INSTALLATION).
 - If leakage is found from other than evaporator, repair or replace it according to the instructions on MS3 online.
4. Verify repair.
