<b>Subject:</b> RUST AROUND REAR VIEW CAMERA AND/OR LIFTGATE OPENER SWITCH	<b>Bulletin No:</b> 09-002/17
	<b>Last Issued:</b> 01/13/2017

2016-2017 CX-3

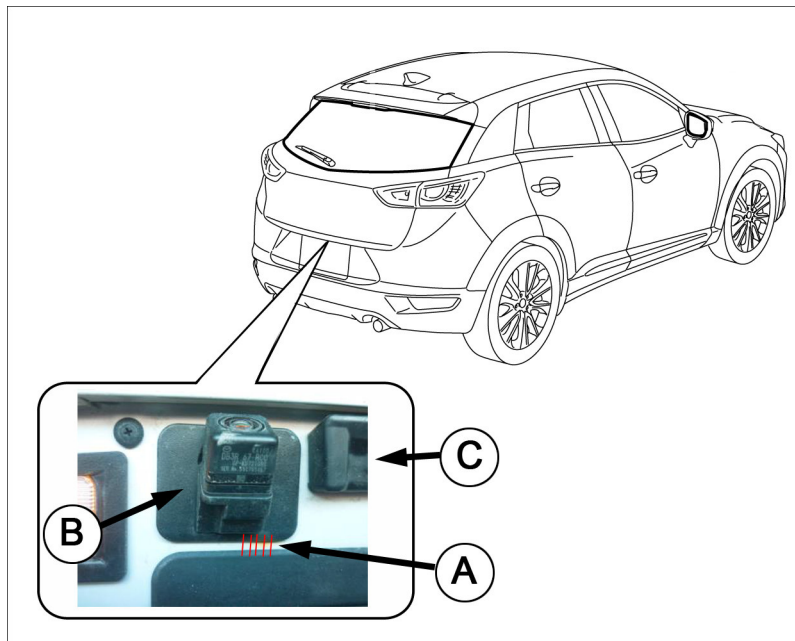
Some vehicles may exhibit rust (A) on the liftgate around the border of the rear mount camera (B) and/or the liftgate opener switch (C). Repair the paint rust and install a pad to prevent future paint rust.

1. Verify customer concern.
2. Repair the affected area of the liftgate by ordinary paint rust damage repair procedure.  
**NOTE:** Repair affected area(s) only. There is no need to repaint the whole liftgate.
3. To prevent direct interference of the rear mount camera and liftgate opener switch mount bases with the liftgate paint surface, attach a protector film (DBY0-62-864) to the liftgate.

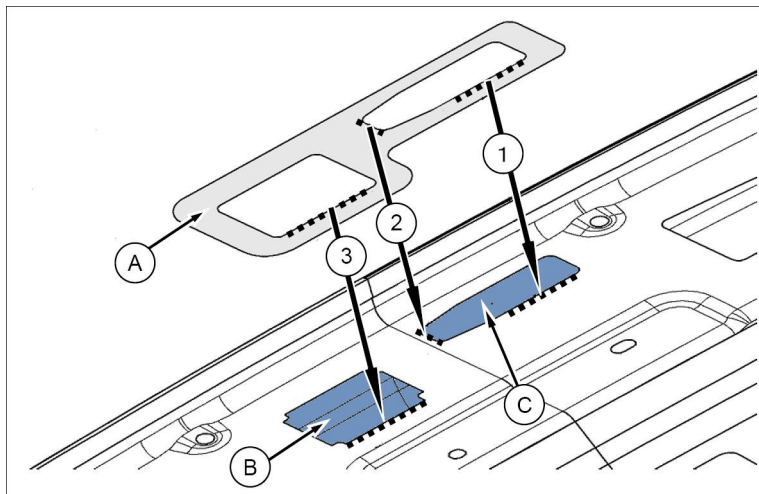
A	Protector Film
B	Installation Hole for Rear Mount Camera
C	Installation Hole for Liftgate Opener Switch

- Degrease the liftgate where the protector film is attached.
- The protector film (A) must not cover the installation holes for the rear mount camera (B) and liftgate opener switch (C). To attach the protector film in the correct position, first align three edges (marked with 1 - 3 in figure) of the protector film with three edges (marked with 1 - 3 in figure) of the installation holes, and then attach the whole protector film without leaving air bubbles.
