Subject: EXCESSIVE OPERATING NOISE WHEN SLIDING FRONT POWER SEAT(S)	Bulletin No: 09-003/17
	Last Issued: 01/13/2017

2016 CX-9 vehicles equipped with power seats with VINs lower than JM3TC*****127218 (produced before Nov. 1, 2016)

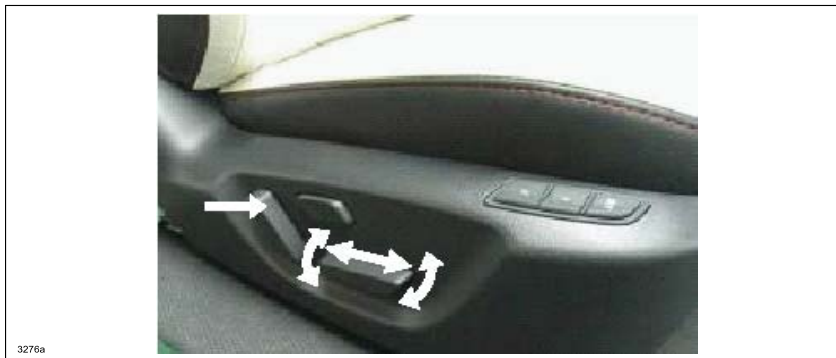
- The repair procedure below is explained using a RH drive model, so the images are shown in reverse.
- To show the cable layout more clearly, the images are shown with the seat cushion removed from the seat frame, however, it is not necessary to remove the seat cushion for this repair.
- Replace the power seat cable with a modified part, only on the seat(s) that are making noise.
