Service Alert No: 1350

Title: 2016-2017 CX-3 EXCESSIVE WATER INTRUSION OR CONDENSATION OF HALOGEN HEADLIGHT
HEADLIGHT

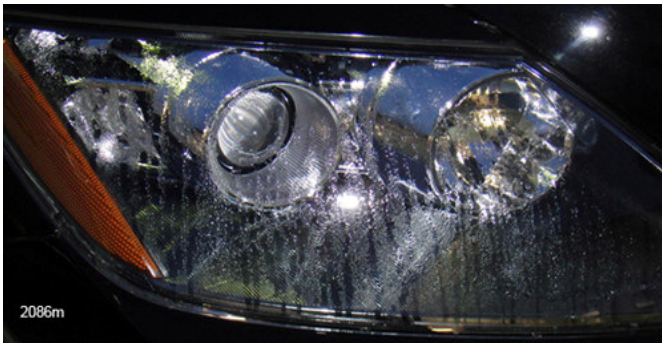
Some customers may complain of condensation/fog inside the front halogen headlight. The halogen headlight assembly may be the cause.

Example of Light Unit With Condensation/Fog That Should Be Replaced

Heavy/large amount of condensation on the lens is not normal.

1. Verify if the condition requires repair. Refer to [TSB 09-003/16](#). Is a repair required?
 - a. Yes - Proceed to step 2.
 - b. No - This service alert does not apply.
2. Check the halogen headlight assembly lot number. Is the lot number before 69S?
 - a. Yes - Replace the headlight assembly.

Note: Verify that the new replacement part has a lot number of 69S or newer.

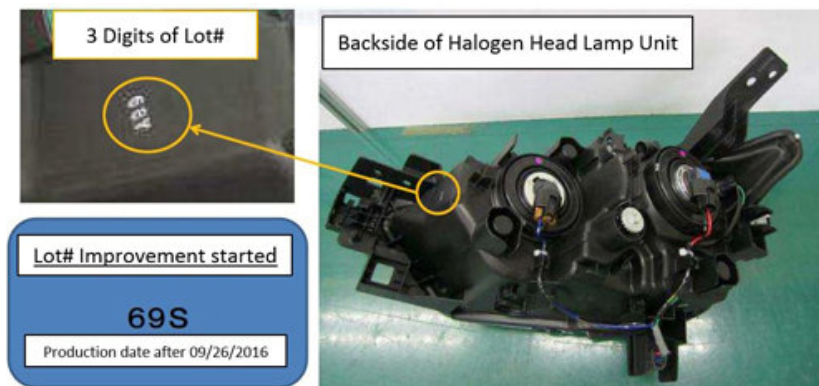
Lot Number Identification

Subjected Headlights are DB4N-51-0K0 and DB4N-51-0L0, Halogen Headlight only
