February 13, 2017

Subject: **Dealer Rework (DRW) 08 - 2016-2017 Mazda CX-9 Lift Gate Hinge Nut Concern**

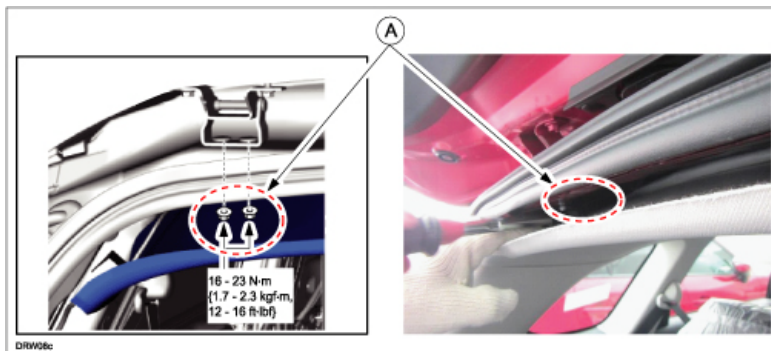
On affected vehicles, the tightening torque of lift gate hinge nuts at cabin side does not meet the specified value. Due to this, it may cause interference/noise with the body when closing/opening the lift gate, or water leakage may occur inside cabin.

Originally the concerned nuts are tightened to the specified torque at the production line. However, the thickness of the packing between the lift gate hinge and body shrinks slightly by heat during paint baking process, resulting in a lowered tightening torque.

4. Tighten the four (4) liftgate hinge nuts (A) on the body side. There are two (2) nuts per side.

**Tightening Torque: 16-23 N-m (1.7-2.3 kgf-m, 12-16 ft-lb, 144-192 in-lb).**
