Technical Service Bulletin

Subject: A/C BLOWS WARM AIR	Bulletin No.: 07-001/17
	Last Issued: 02/15/2017

2016-2017 CX-3 vehicles with VINs lower than JM1 DK ***** 159395 (produced before November 01, 2016)

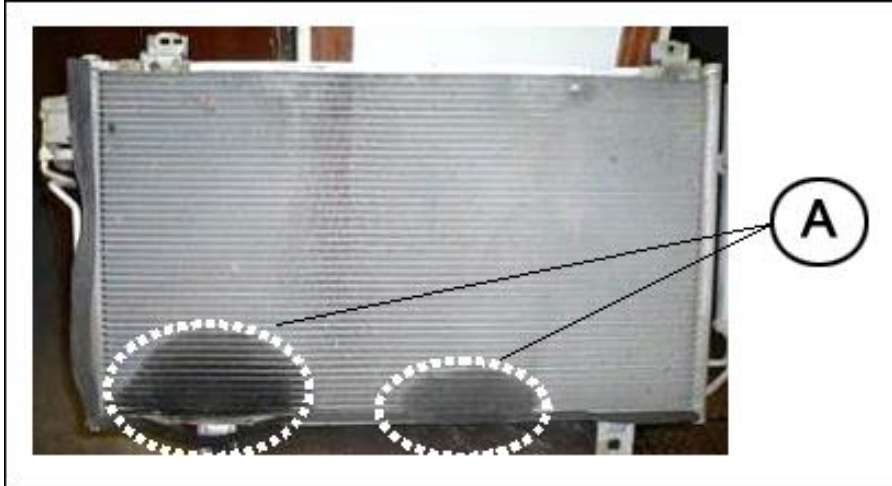
Some customers may complain about warm air from the climate control vents. This may be caused by condenser corrosion, causing a refrigerant leak.

1. Visually inspect the condenser for A/C refrigerant leak. Is there a visible trace of A/C refrigerant leak at location (A)?

3. Replace the condenser. Refer to MS3 online Workshop Manual CONDENSER REMOVAL/INSTALLATION [SKYACTIV-G 2.0].
