Technical Service Bulletin

Mazda North American Operations
Irvine, CA 92618-2922

Subject: CONVERTIBLE TOP INNER CLOTH FALLING DOWN CAUSING POOR APPEARANCE AND OBSTRUCTING VIEW OF BACK WINDOW	Bulletin No.: 09-005/17
	Last Issued: 02/17/2017

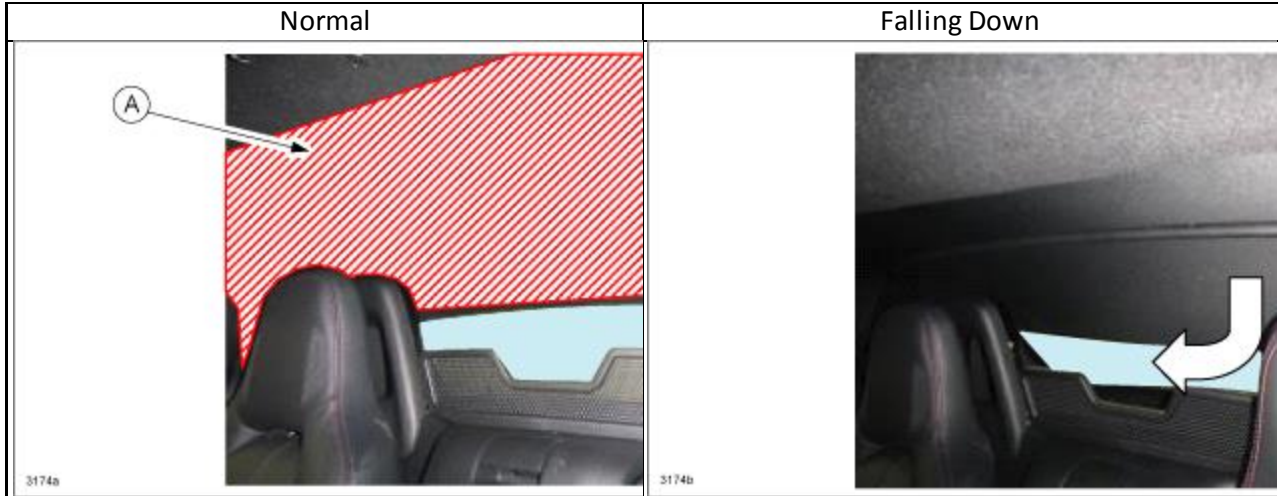
Some vehicles may exhibit the inner cloth (A) falling down at the rear end causing a poor appearance and obstructing the view of the back window.

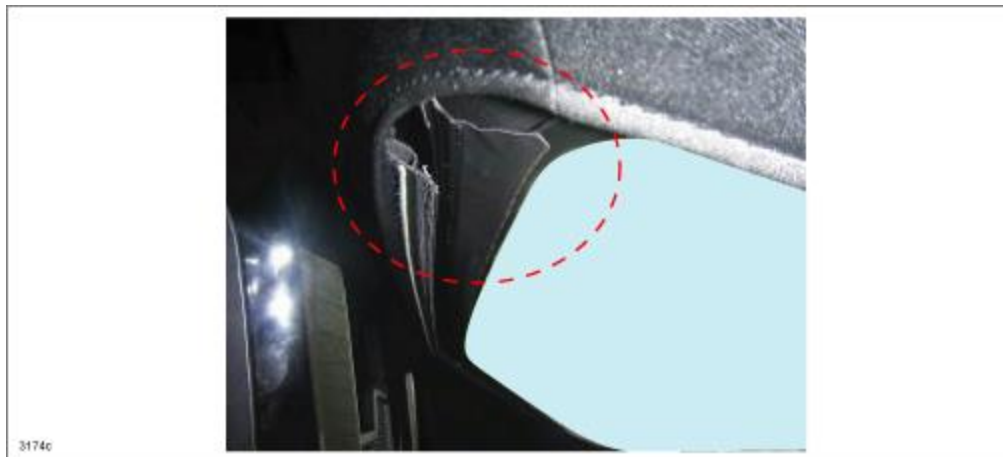
This is caused by

CASE A: The J-hook binding holding the inner cloth coming loose because the convertible top is opened/closed a lot or from high ambient temperatures.

CASE B: After the previous improvement carried out at the supplier since January 19, 2016, some J-hooks have still been found coming loose to bind and hold the inner cloth during the assembly process.

CASE A: Two top-protector clips have been additionally installed to both side edges of the J-hook to prevent the J-hook from loosening and separating.

CASE B: An improved inspection process has been started at the supplier to check the appearance of the inner cloth after installation of the clip.

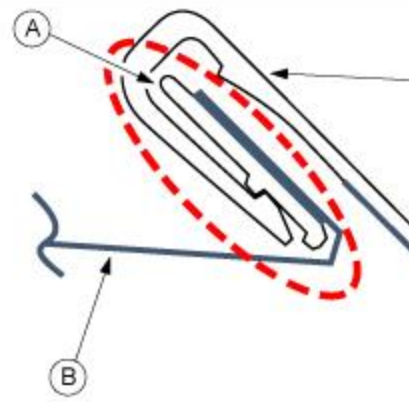
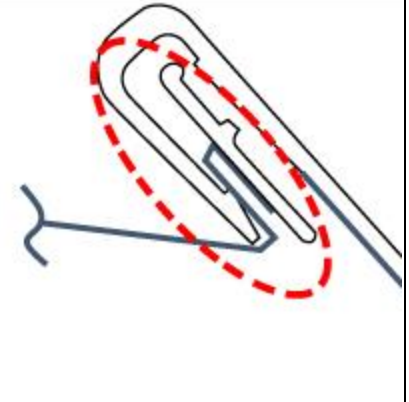
NOTE: Make sure to turn over the resin edge (A) of the tension cloth (B) to the correct direction as shown so that the hook of the tension cloth engages correctly in the J-hook.

OK (Two hooks are engaged correctly)	Not OK (Resin edge of tension cloth is turned over in wrong direction)
