Technical Service Bulletin

Subject: 09-019/17 - Fctry MESSAGE DISPLAYED AFTER INSTRUMENT CLUSTER REPLACEMENT	Bulletin No.: 09-019/17
	Last Issued: 05/24/2017

2016-2017 Mazda2	2016-2017 CX-3	2016-2017 CX-9
2014-2017 Mazda6	2017 CX-5

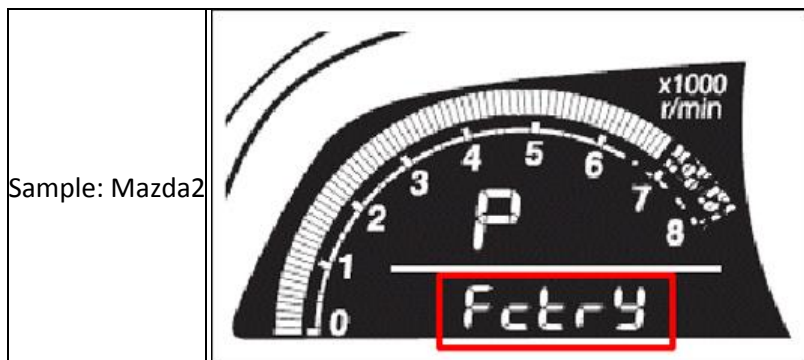
After the installation of a new instrument cluster, the message "Fctry" is displayed instead of the odometer.

Some new instrument clusters are in the factory mode setting. Factory mode cancellation is required.

NOTE: The concern is applicable to Calsonic Kansei instrument clusters. Not all trim levels are affected.
