Subject: FRONT SHOCK ABSORBER DUST BOOT CRACK	Bulletin No.: 02-009/17
	Last Issued: 11/10/2017

2014-2015 Mazda6 with VINs lower than JM1 GJ ***** 167304 (produced before January 6, 2014)
2016-2018 CX-9 with VINs lower than JM3 TC ***** 211169(produced before October 3, 2017)
2013-2015 CX-5 with VINs lower than JM3 KE ***** 430754 (produced before January 6, 2014)
2017 CX-5 with VINs lower than JM3 KF ***** 222099(produced before October 3, 2017)

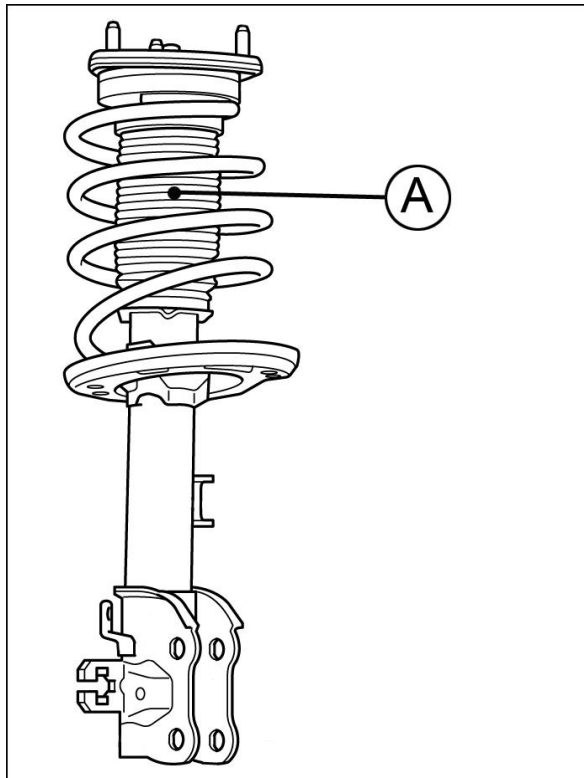
Some vehicles may exhibit a crack on the front shock absorber dust boot (A). This may be caused by dust boot insufficient resistance to cold. The shape and material of the dust boot has been changed to improve the resistance to cold.

Customers having this concern should have their vehicle repaired using the following repair procedure.
