# Technical Service Bulletin

**EXCESSIVE OPERATING NOISE WHEN SLIDING POWER SEAT**

**Bulletin No.:** 09-011/17

2014-2017 Mazda6 vehicles equipped with power seats 2013-2016 CX-5 vehicles equipped with power seats with VINs between JM3KE \*\*\*\*\*\* 100063 - 893935 (produced from December 15, 2011 to November 1, 2016)

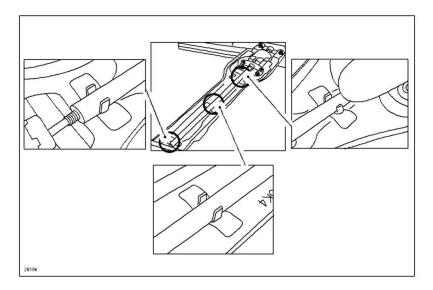
13. Press the cable from above with your fingers to secure it in the (3) three brackets shown below.
