FRONT STEP MOLDING FALLEN OFF AFTER DRIVING ON SNOW AND ICE

Bulletin No.: 09-045/17

2016-2018 CX-3

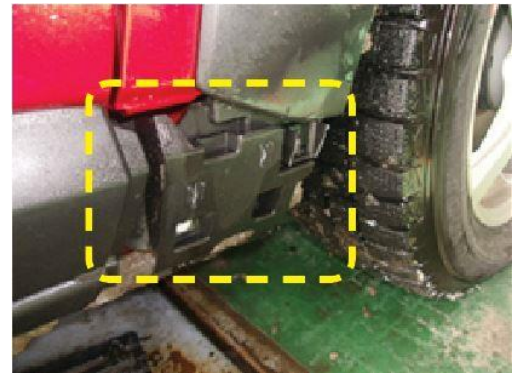
Some customers driving on snow and ice may find the front step molding fallen off. This may be caused by snow and ice accumulated under the molding when contacting a snow pile. The front step molding structure may not be strong enough to hold under certain conditions.

Customers having this concern should have their vehicle repaired using the following repair procedure.

1. Verify customer concern.
2. Replace the front step molding on the affected side. Refer to MGSS online Workshop Manual SIDE STEP MOLDING REMOVAL and SIDE STEP MOLDING INSTALLATION.
3. Verify repair.
