Subject: MULTI-MODEL - ELECTRICAL CONCERN DUE TO AFTERMARKET DEVICE	M-Tips No.: MT-017/17
	Last Issued: 11/02/2017

APPLICABLE MODEL(S)/VINS

Mazda2 2011-2018	Mazda6 2007-2017	CX-7 2007-2012	RX-8 2007-2011
Mazda3 2007-2018	CX-3 2016-2018	CX-9 2007-2018	
Mazda5 2007-2010, 2012-2017	CX-5 2013-2017	MX-5 2007-2018

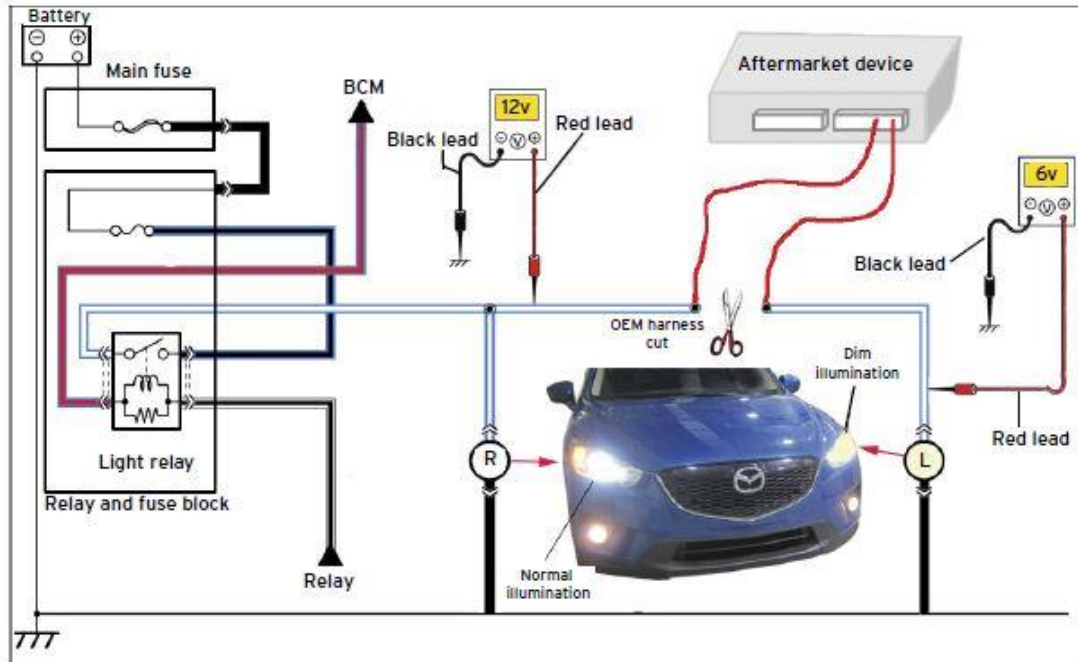
Some aftermarket devices that are wired to the vehicles's wiring harness may create unusual electrical symptoms and/or store DTCs. Below is an example of a dim headlight. The aftermarket device changed the headlight circuit resistance, causing a dim headlight.
